## Biological and corrosion aspects of a multi-stage flash seawater desalination plant after deaerator modification

Deaeration units of a commercial multi-stage flash (MSF) cogeneration facility underwent venting modifications to increase system distillate productivity without increasing energy consumption or elevating top brine temperatures. Three MSF units were investigated after oxygen levels of deaerators spiked above design limits (20 ppb). The investigation found a significant biotic presence in the deaerator unit's MSF heat rejection sections that included algae, bacteria, bivalves, and bivalve larvae. The bivalve taxa consists of *Barbatia parva*, *Diodora funiculata*, *Pinctada margaritifera*, *Amiantis umbonella*, and *Acrostergma assimile*. Galvanic corrosion exacerbated by biofilm was also observed in heat rejection sections. While attesting to the tenacity and adaptability of marine life, the presence of biological communities is symptomatic of the abnormally high oxygen levels in deaerator units. Elevated oxygen levels contribute to systems performance declines resulting from biological fouling of deaerator packing materials, partially responsible for inefficiencies

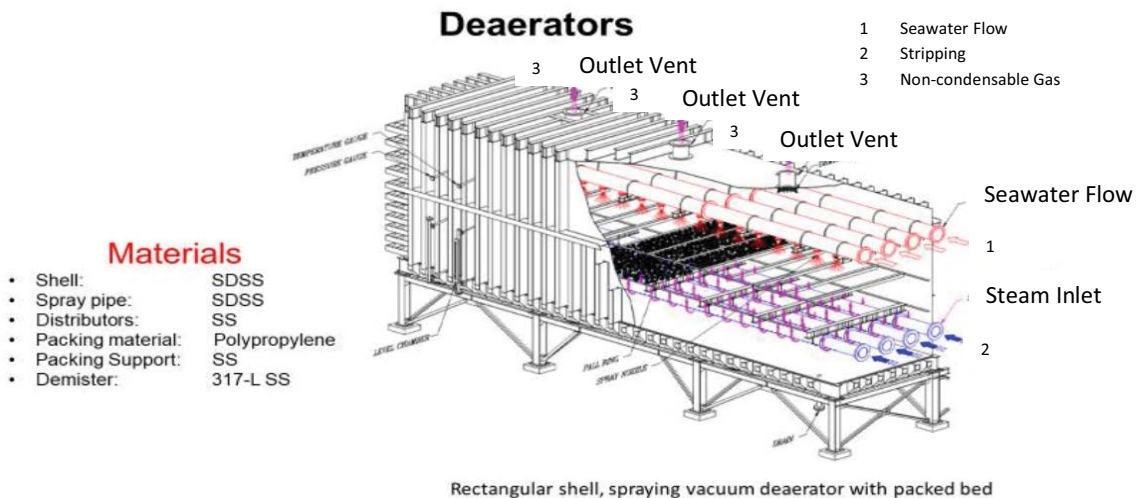
Fig. 1. A deaerator unit with inspection demarcations (cogeneration desalination unit).

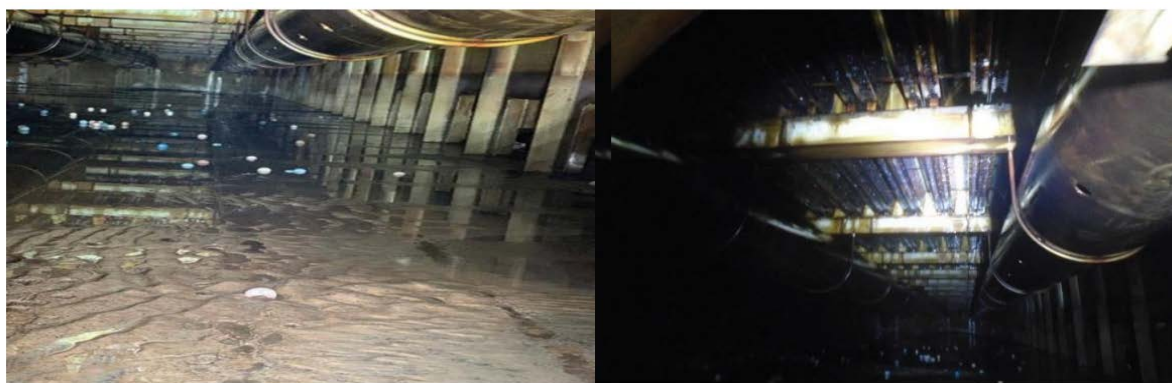
The area of the deaerator beneath the packing material contained sand with black particulates (Fig. 3). Balls from the ball cleaning system were also found. In addition, noticeable reddish streaks were observed on metal steam lines at the base of the packing support structure and struts holding steam lines – presumably due to iron oxide formations.

Fig. 3. Lower area of deaerator (unit 73).

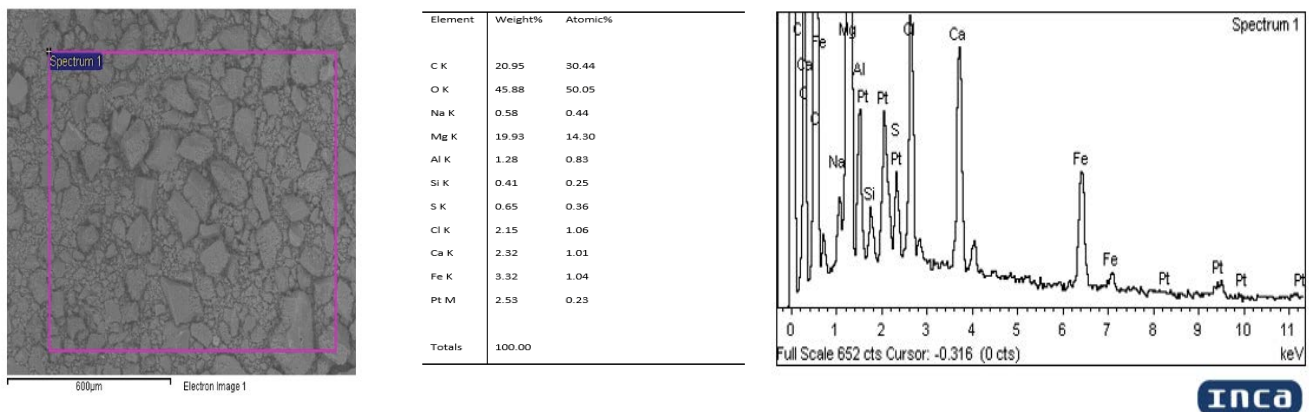
Samples of material obtained from beneath the gasket attached to the maintenance hole door appear to contain sulfur and iron (Fig. 4) – confirmed by SEM/EDX. In addition, high percentages of magnesium, carbon, and oxygen are observed (Fig. 4), in addition to trace concentrations of aluminum and silica.

Iron and magnesium can indicate corrosion products in the form of oxides, which also suggests the presence of oxygen oxidation in the deaeration feed water. In the EDX results, sulfur is also observed, explaining rubber vulcanization's faint but pungent smell [4]. Gasket performance failure is most prominent at the bottom of the manhole door (Fig. 4). Improper gasket sealing around the maintenance hole results in air leakage, vacuum losses, and system performance reduction. Material biodegradation is suspected to be a cause of the mechanical seal (gasket) detachment. Copious amounts of slime material were observed under the gasket's areas, and high carbon and oxygen ratios (SEM/

EDX) confirmed biofilm presence (Fig. 4). Silica is most likely associated with sand (in the deaerator system) and diatomaceous material (Figs. 5 and 6).

Fig. 4. Scanning electron microscopy/energy-dispersive X-ray spectroscopy results for samples collected under the gasket of the deaerator manhole.

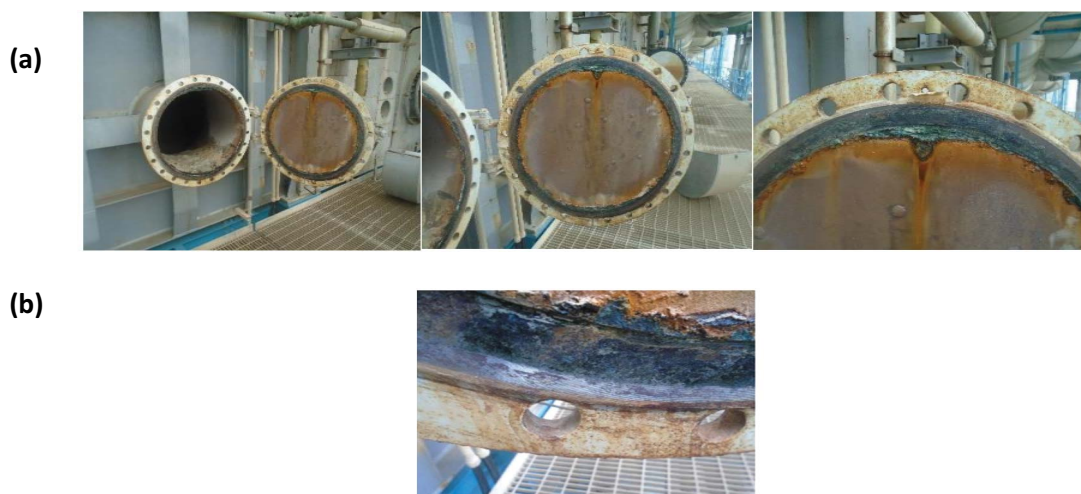
Copious amounts of sludge comprised of organic and diatomaceous materials were found at the bottom of the deaerator (Fig. 5), as confirmed by microscopic. A significant portion of a black substance (with a distinct  $H_2S$  smell) under the top layer of the sludge contained sulfur-reducing bacteria (BART-SRB test) and iron related bacteria (BART-IRB test), respectively (Fig. 6).

Fig. 5. Lower maintenance hole door of unit 71 (a) with gasket and (b) without gasket.

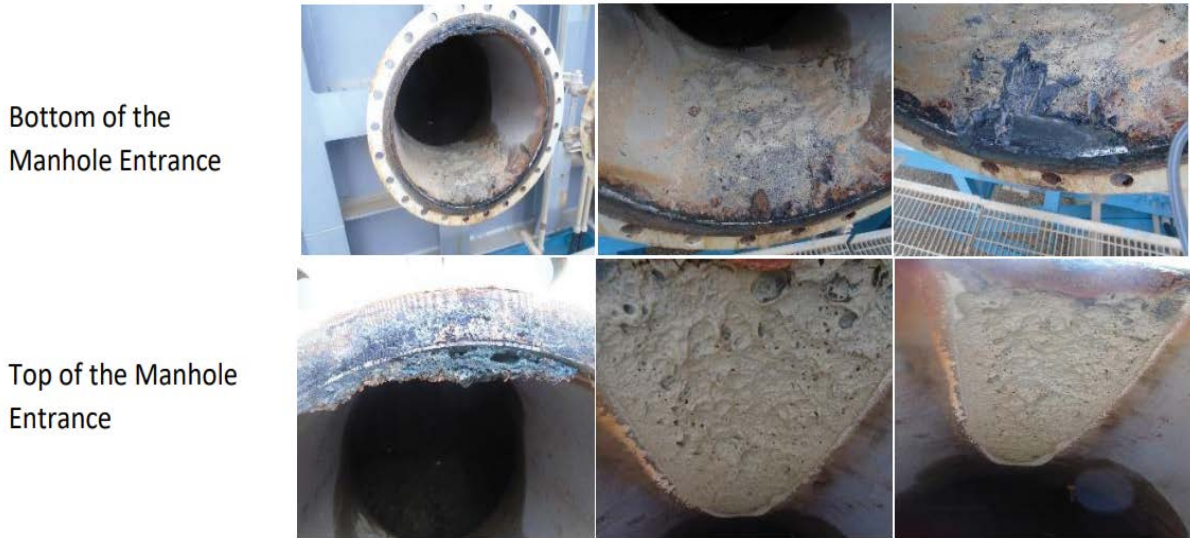
Deposits collected from the maintenance hole door and entrance to the deaerator contain iron deposits, organic material, diatomaceous matter, and microbes. Bivalve larvae were the dominant biota (by size) under microscopic examination (Fig. 7). Bacterial isolates were rod and cocci shaped with ciliated movements.

Fig. 6. Deposits on the maintenance hole door, manhole entrance, and inside of the multi-stage flash deaerator.

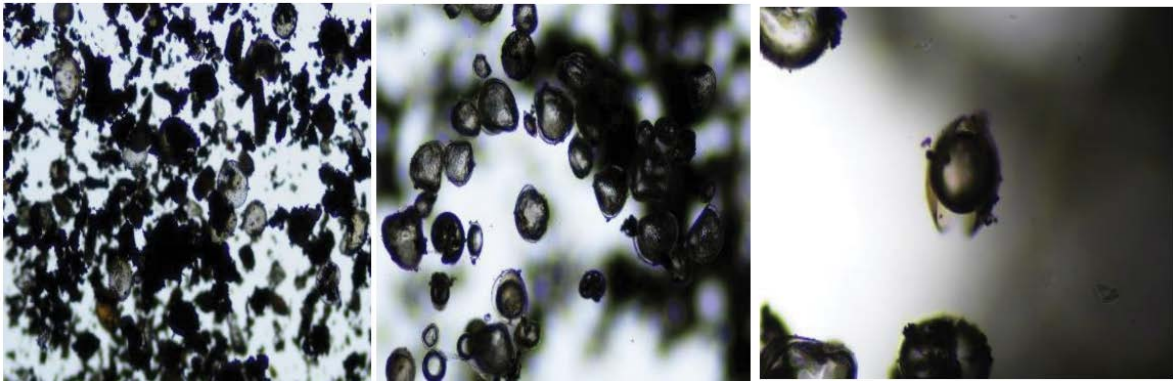
Fig. 7. Microscopic profile of species extracted from the manhole door, entrance, and inside of the deaerator (predominance of bivalve larvae).

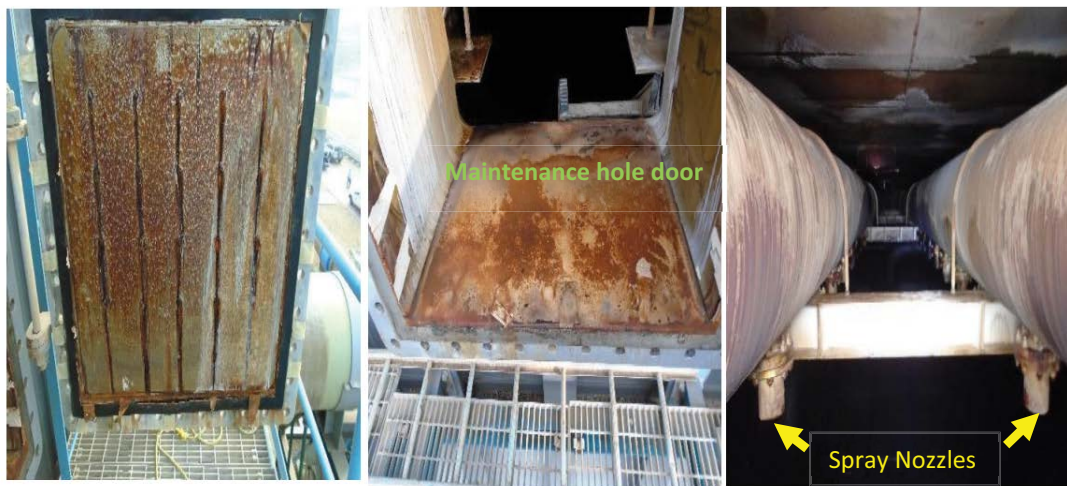
Some surface oxidation was noticed on the interior near the maintenance hole door without indicating signs of metal oxidation (Fig. 10).

Fig. 10. Deaerator above the packing – manhole entrance and internal compartment.

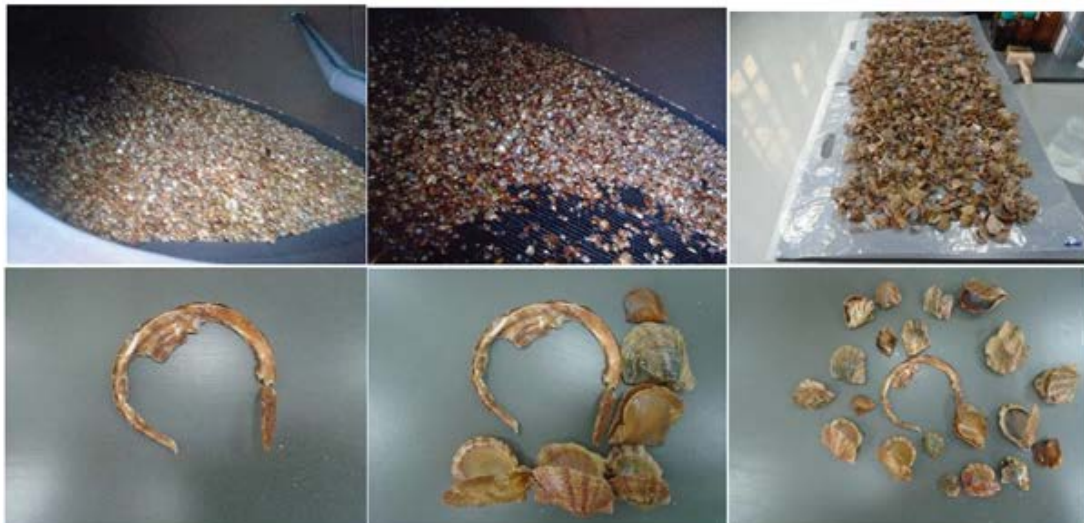
Large numbers of viable, mature bivalves were observed in the area where the cooling water discharges from the heat rejection system – after traveling through tube bundles of stages 23, 22, and 21 (Fig. 12). *Barbatia parva*, *Diodora*

*funiculata*, *Pinctada margaritifera*, *Amiantis umbonella*, and *Acrostergma assimile* were observed. The ages of bivalves are estimated at between six months and 2 y – taking into account the combined theories of Kleiber [6], Kooijman [7], and Peters [8]. The location of these shells covering the separation grate can promote seawater degassing, producing pressurized zones within the system resulting in mechanical stress on glass fiber reinforced polymer – resulting in delamination, leaks, and cracks (Fig. 13).

Fig. 12. Mature bivalves at the discharge of heat rejection system of unit 73.

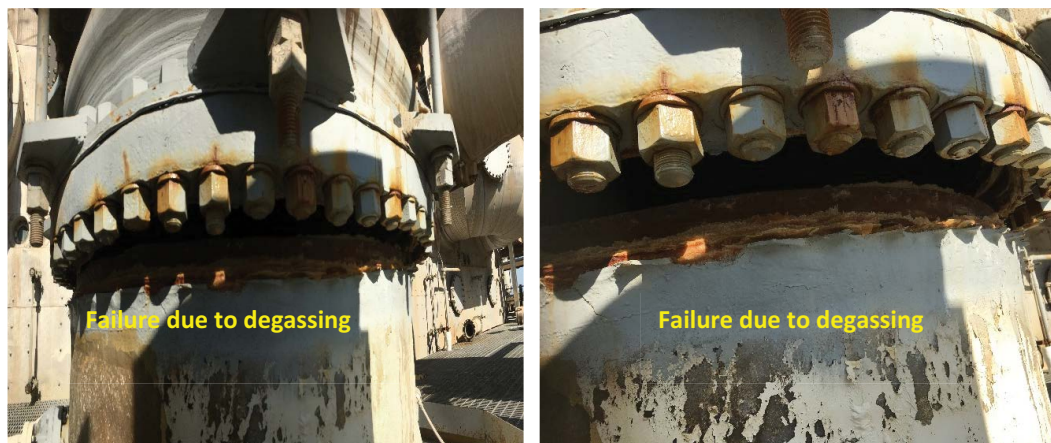
Fig. 13. Glass fiber reinforced polymer damage due to pressurized oxygen build-up from the deaerator feed lines from the heat rejection section of a commercial Arabian Gulf multi-stage flash plant.

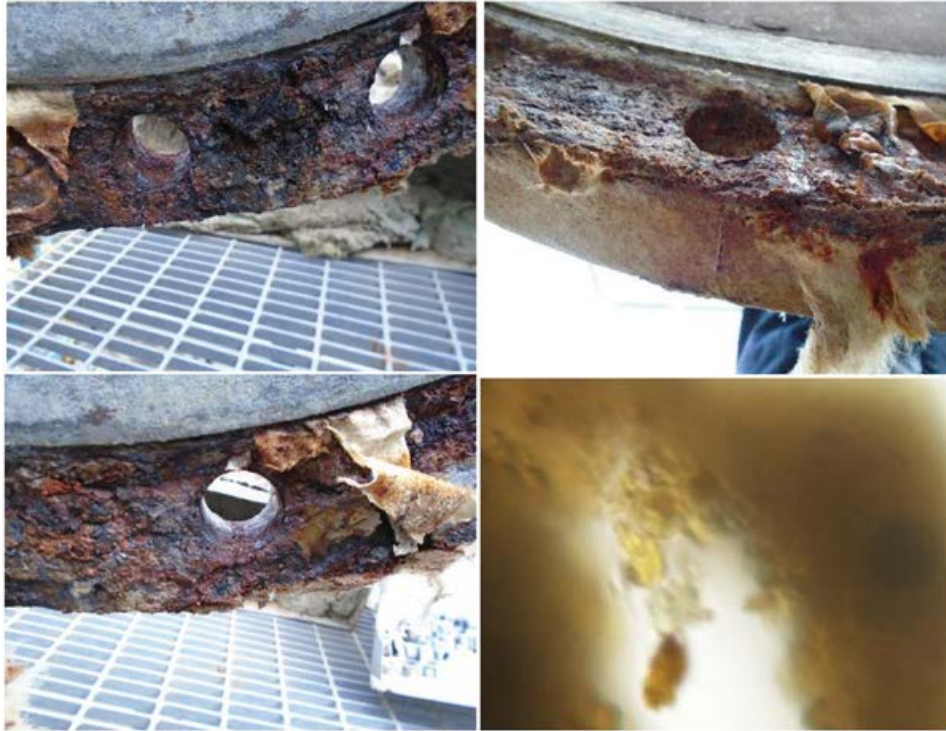
Stage 22 of the heat rejection system experienced crevice corrosion that accelerate galvanic corrosion due to the contact of different metals and the presence of a galvanic couple. Small areas of exposed metal accelerate the corrosion rate from anode/cathode concentration points that promote more electron/proton exchange leading to metal degradation. Upon detailed inspection, pitting corrosion is also observed. Iron-associated bacteria (from the BART IRB test) and microbial biofilms (from microscopic examinations) were present (Fig. 14). Iron-associated bacteria and biofilm suggest the existence of microbially induced corrosion (MIC), which can exacerbate crevice and galvanic corrosion.

Fig. 14. Galvanic and pitting corrosion with microbially induced corrosion.

- Further, investigate the deaerator packing material for biofouling resulting in process declines;
- Change the gaskets of the maintenance holes of the deaerator and heat recovery system to gaskets more resistant to microbial attack and low water absorption;
- Inspect the system thoroughly for leaks with proper routine maintenance;
- Inspect the intake travel screens, process seawater feed lines, and seawater cooling water systems for macro-fouling species and their larvae;
- Inspect and remove corrosion products and repaint maintenance holes (in the heat rejection section) with non-corrosive paints;
- Paint fixing screws with epoxy to reduce bi-metallic galvanic corrosion and follow the recommended bolting torque values to avoid gasket damage.

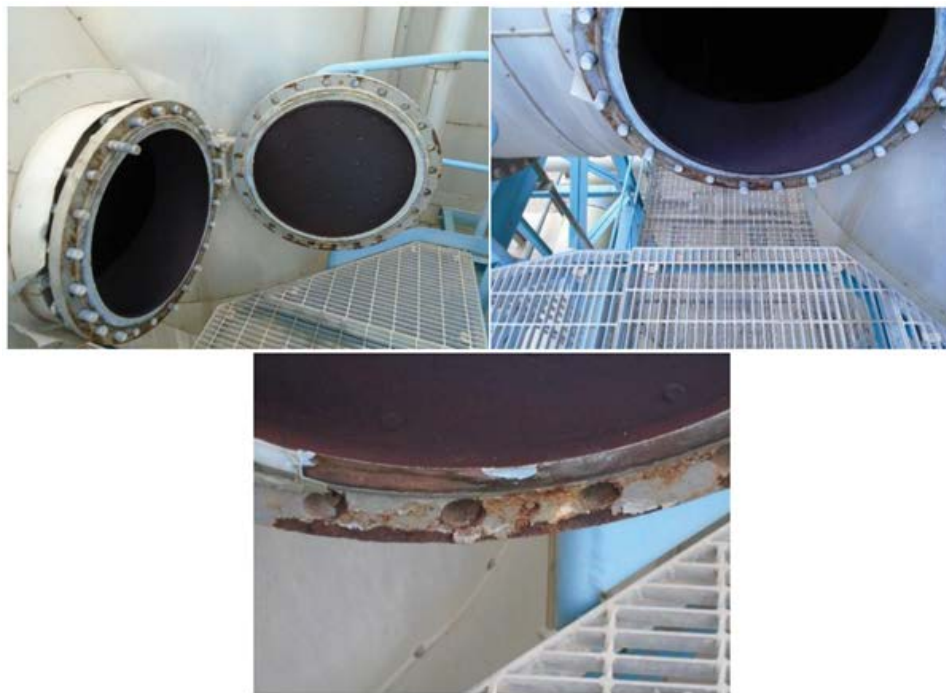
Cuts and tares in asbestos gaskets were observed in stages 21 and 22 of the heat rejection section (Fig. 15).

The causes of the material failure appear to be an installation defect resulting in water seepage into fibers. Asbestos gaskets are durable and resistant to high temperatures. However, using asbestos gaskets in water treatment systems poses health risks to humans (during installation and replacement) and ecological hazards to aquatic organisms if leached back into seawater. Therefore, industries are increasingly turning to high-performance gaskets made from graphite: clavar, or PTFE, as replacements for asbestos [11].

Fig. 15. Unit 23 asbestos gasket removal and protective paint removal.

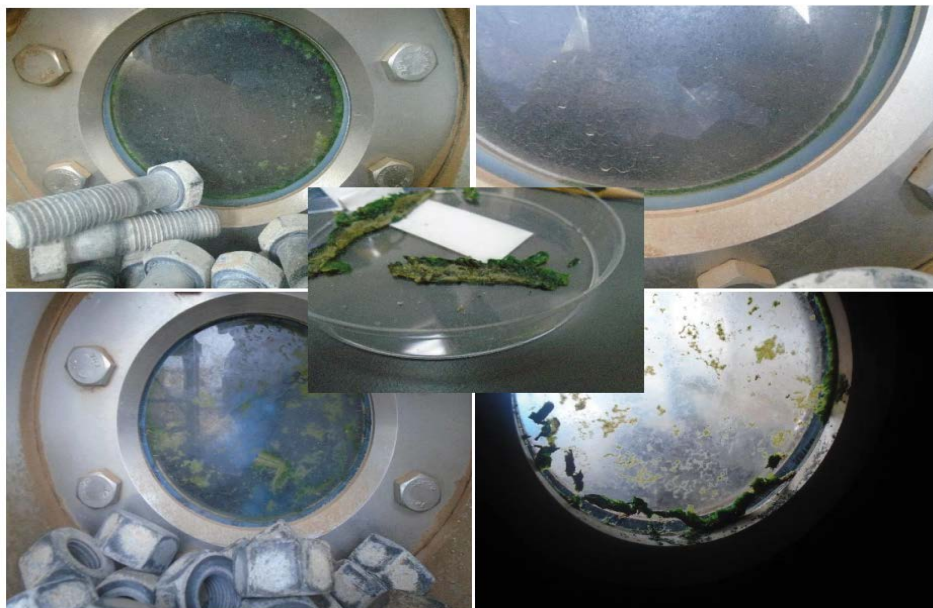
Sight glass damage was observed in some MSF units (unit 76). While there was no sight glass damage in unit 73, algal growth was evident on gaskets around the looking glass of chambers 21 and 22 of the heat rejection system (Fig. 17). Algal growth indicates gasket defects and air seepage into the vacuum system. The presence of light, air leakage, moisture, favorable temperatures, and the rough surface of the gasket (that also contained scale deposits) are ideal conditions for algal growth. To correct the problem of the vacuum leak within the heat recovery section. For unit 73, gasket replacement, repair of the looking glass,

Fig. 17. Multi-stage flash unit 73 looking glasses (chambers 21 and 22).

disinfectant (with DBNPA [a non-oxidative biocide]) followed by a system air leak inspection was recommended. For unit 76, gasket replacement, disinfection, and change of sight glasses followed by a leak test were advised.
