Control of severe membrane silica scaling: investigation and trouble shooting

Located in the northeast of China and established in 2009, the LiaoNing Panjing power company is the only energy supplier of the Panjing Liaoabin economic zone (400 Km²). The power generation requires demineralized water coming from the power plant water treatment facility, which consists of a primary filtration step followed by RO trains and ion exchange resins.

At the end of 2011, the RO plant performance severely dropped—normalized flux declined by 50%—indicating an occurrence of fouling or scaling on the membranes. The performance change triggered initiation of a technical investigation in order to restore RO performance. Detailed feed water quality analysis, RO plant inspection, and deposit analysis were carried out, and severe silica scaling was found as the cause.

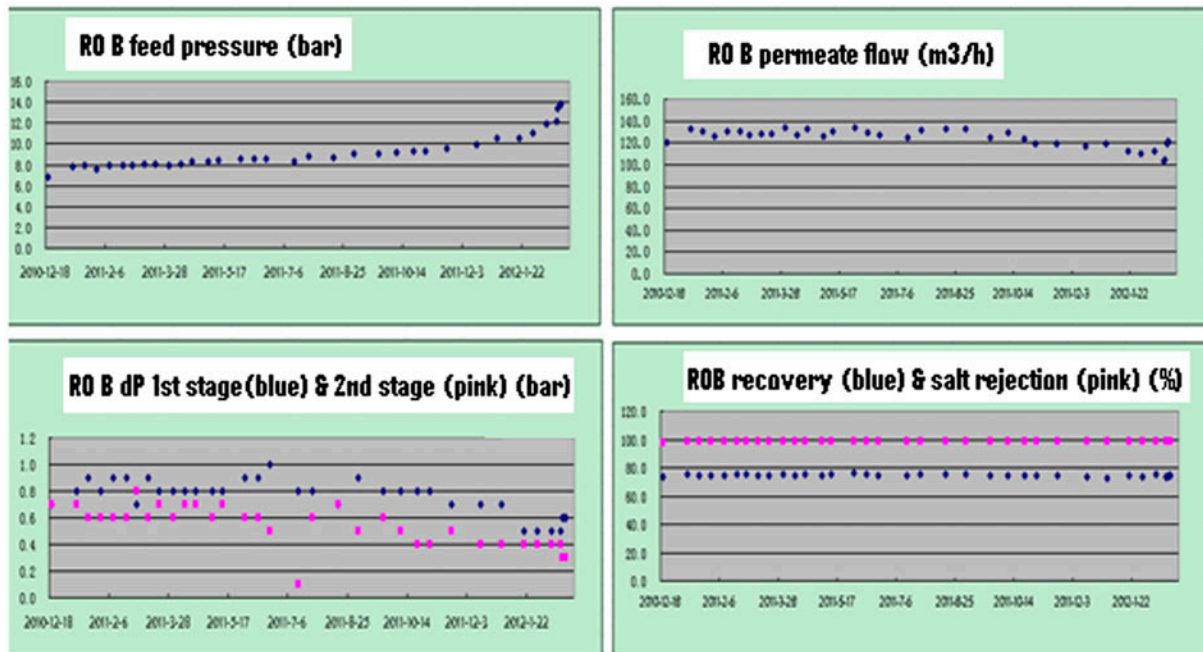
Fig. 2. RO operational parameters monitoring.

As shown in Fig. 2 below, the RO performances started to drop at the end of the year 2011 with a fast decline observed at the beginning of the year 2012.

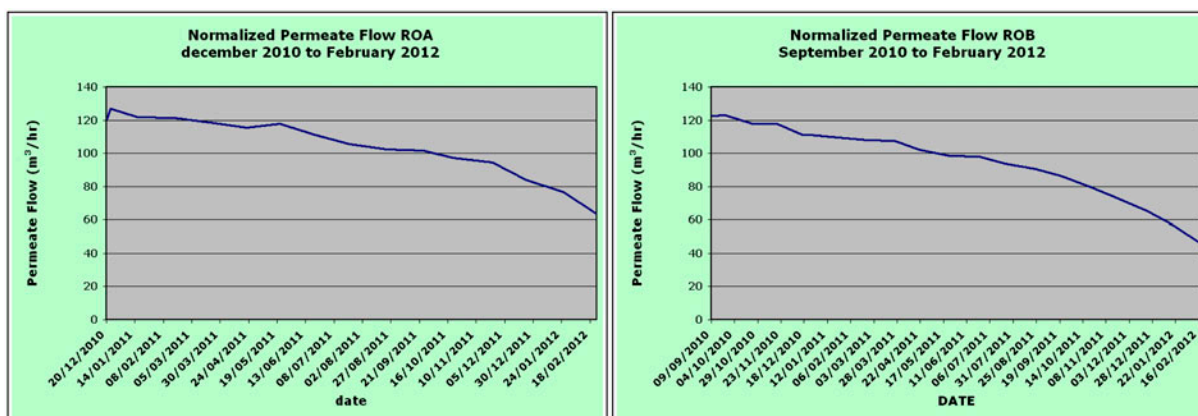
Fig. 3. RO normalized permeate flow year 2010–February 2012.

decrease by 50% (Fig. 3), a slight increase in salt passage, and a fluctuating pressure drop.

In February 2012, the general RO performance was tremendously negatively impacted.

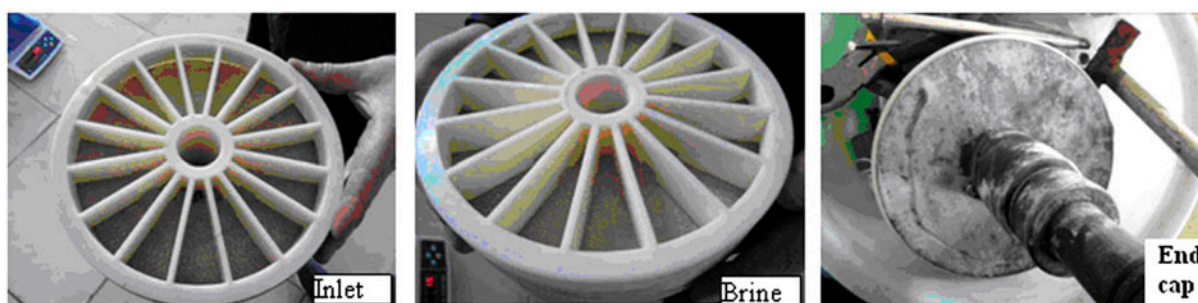
Fig. 4. Membranes pictures.

RO pressure vessels in the first stage and second stage were opened at the feed (inlet) and brine (outlet) sides. A thin layer of white deposit was found on the end caps, upon evaporation. The white deposit is more obvious on first stage brine side and second stage inlet side as shown in Fig. 4 below.

The deposits contain mostly silicon and oxygen with traces of aluminum and calcium

Investigations confirm that the loss in RO performance is due to a silica-based scale with a co-precipitation of aluminum and calcium.

Based on the various analyses [2–4], two optimization steps were adopted. First, an efficient cleaning protocol was requested and developed in order to avoid membrane replacement. Secondly, the application of a powerful silica scale inhibition antiscalant was needed to reduce further scale development.

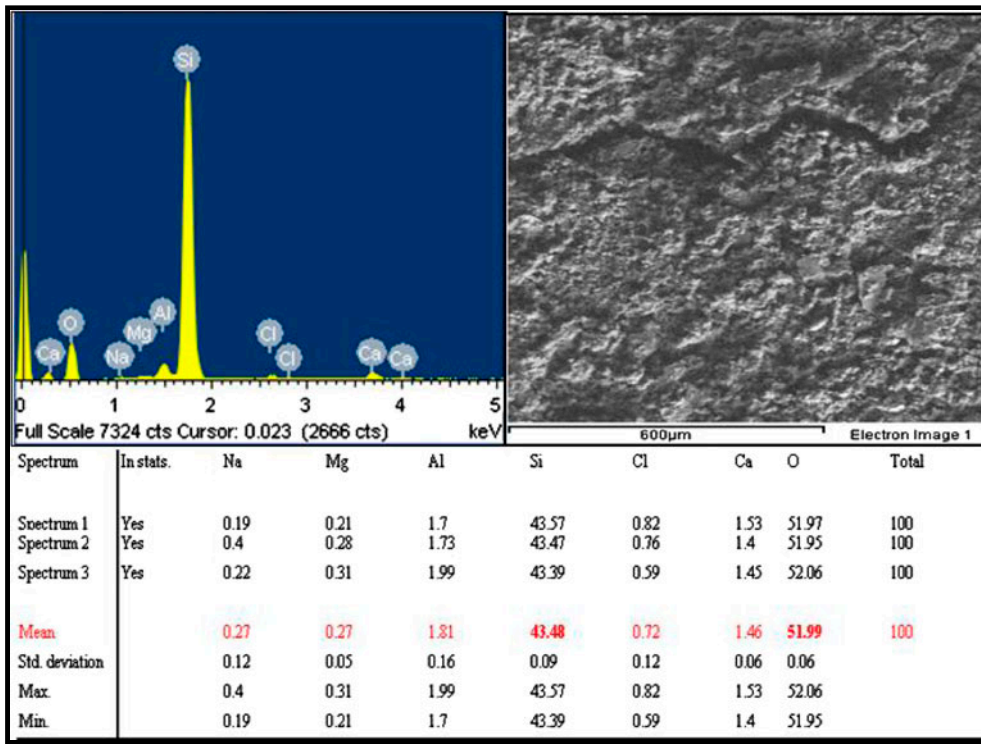
Table 4
SEM results

The white deposit (second stage feed side) was sent for SEM analysis in order to screen its mineral composition. The results are in Table 4.

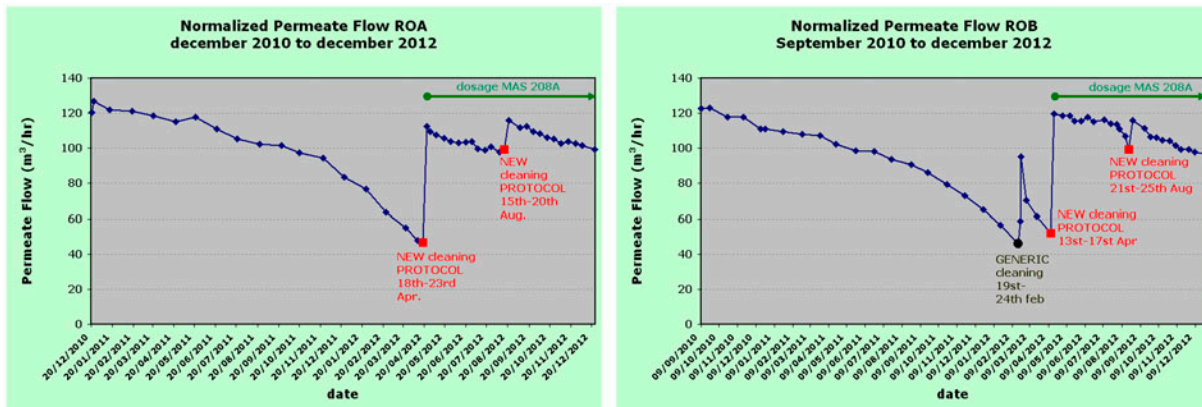
Fig. 5. RO normalized permeate flow before and after the trouble shooting year 2010–December 2012.

- (2) The plant generic cleaning [5] was not effective (Fig. 5).

Fig. 5 shows the effectiveness of the cleaning by comparing operational parameters before and after this new cleaning protocol. After cleaning, the RO performances were restored to normal operational ranges.

- (1) Step 1: Alkaline cleaning solution composed by MCC241 [6] commercialized by ShiBoHengYe company mixed with STPP (sodium tri polyphosphate).
- (2) Step 2: Alkaline cleaning solution is composed by MCC241 commercialized by ShiBoHengYe company mixed with Na₄-EDTA (tetra sodium salt of ethylenediaminetetraacetic acid).
- (3) Step 3: Acid cleaning done with citric acid.

MAS 208A was instituted immediately after the new cleaning protocol in April 2012. Fig. 5 shows that RO performance was stable since cleaning, and the MAS 208A antiscalant is still currently being used with success.
