Autopsy of RO desalination membranes Part 1. Microbial characterization of foulants

G. Schaule^{a,*}, S. Rapenne^b, M. Strathmann^a, S. Grobe^a, C. Robert^b, V. Jacquemet^b

Comprehensive autopsies of RO membrane elements from a seawater desalination plant were performed before and after chemical cleaning. The RO membrane elements (FILMTEC, SW30HR LE-400 8") selected for the autopsy studies have been in service for nearly 2 years and were located in front position of a pressure vessel from the first pass of one of the RO units. Process performances have been quite stable for the whole period of operation. Before and after chemical cleaning both membrane elements showed a visible deposit on the membrane surfaces with wet matter of 27 g/m² (before) and 11 g/m² (after) cleaning. By ICP-OES analyses before cleaning, a high content of iron and manganese was found in the deposit. After chemical cleaning, most of the parameters remained stable except the manganese content which was not detected any more. The autopsies underlined the presence of a biofilm even if no obvious loss of membrane performances was observed. The high content of manganese and iron in combination with the microscop

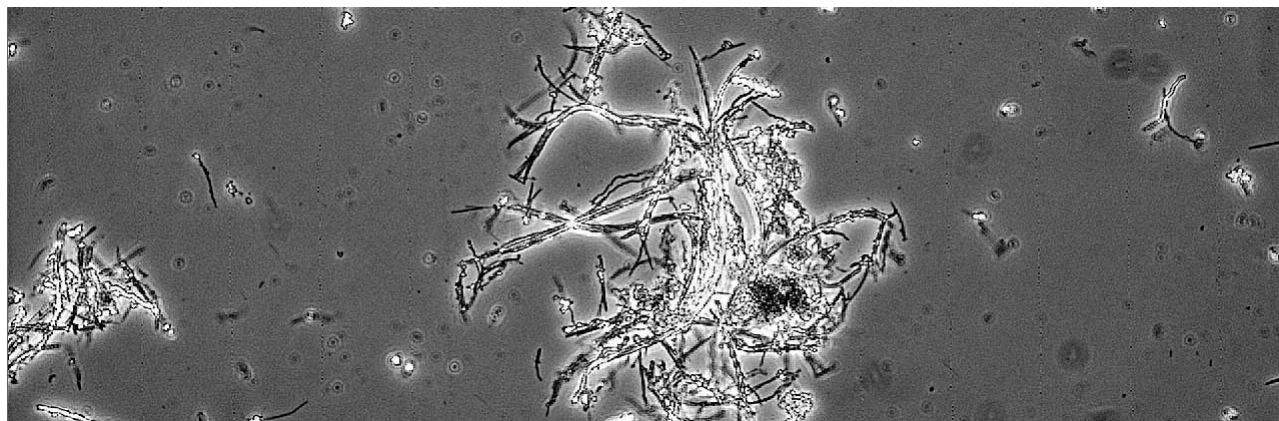
Fig. 1. Light microscopic image of a microbial aggregate showing typical structures of iron and/or manganese-oxidising bacteria and their metabolites as well as iron deposits.

However, it was difficult to clearly identify the structures within the heterogeneous matrix even if the light microscope investigation showed a lot of iron deposits and typical structures known from iron and manganese-oxidising bacteria.

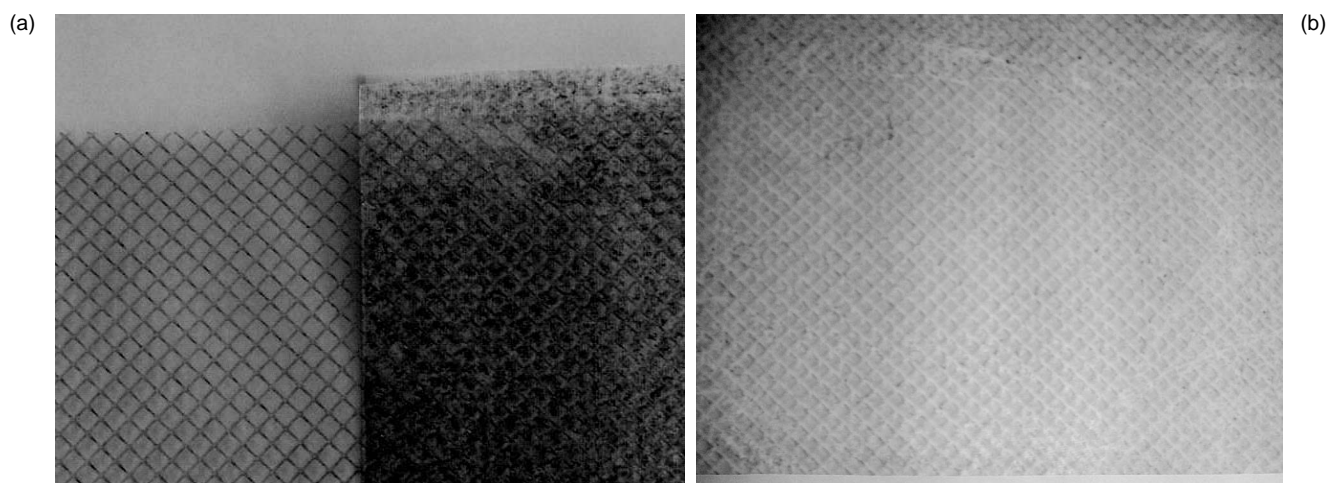
Both membrane elements investigated showed a visible deposit at the membrane surfaces which was slightly unevenly distributed. There was no layer or precipitates on the spacer. The brownish deposit layer could be easily mechanically scrapped from the membrane surface (Fig. 2). After cleaning the layer was thinner and the colour less intensive (Fig. 2b).

Fig. 2. Optical view of the membrane surface and the spacer before cleaning (a) and after cleaning (b).

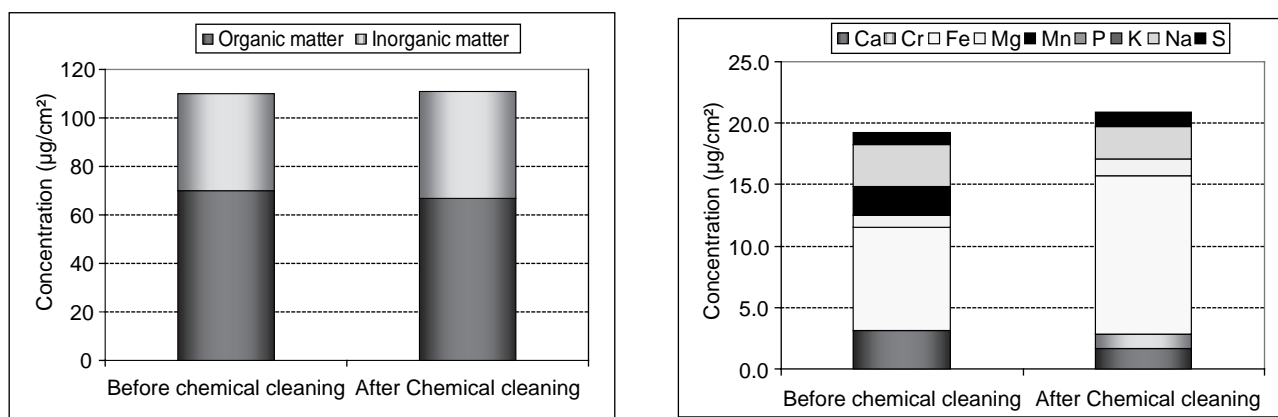
For comparison, the results obtained by another partner are presented in Figure 3. They are in the same order of magnitude. The dry matter content and the proportion of organic/inorganic remained stable despite the cleaning. After chemical cleaning, manganese was not detected any more but iron showed a high concentration as before cleaning (Fig. 3).

Fig. 3. Organic and inorganic content of the deposit scrapped on the membranes before and after cleaning (partner 2).

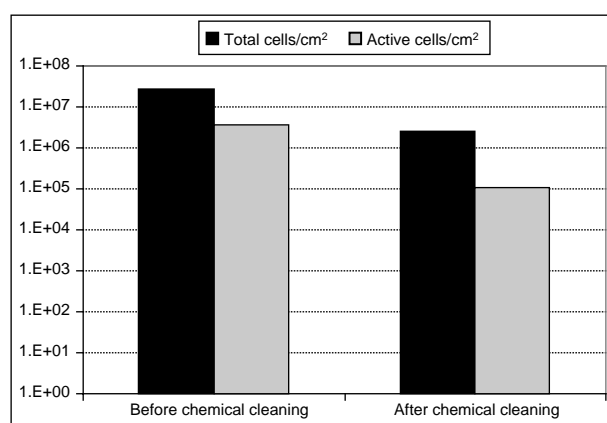
Total number of bacteria was found at a high level of 3×10^7 bacterial cells/cm² before cleaning and 2×10^6 cells/cm² after cleaning (Fig. 4). These results were in the same order of magnitude for both partners. Moreover, a significant decrease of the active bacteria concentration was noticed after cleaning. But, even if a slight decrease was observed, the concentration level of total bacteria remains high after cleaning.

Fig. 4. Microbial content measured as total cell number of the deposit scrapped on the membranes before and after cleaning.

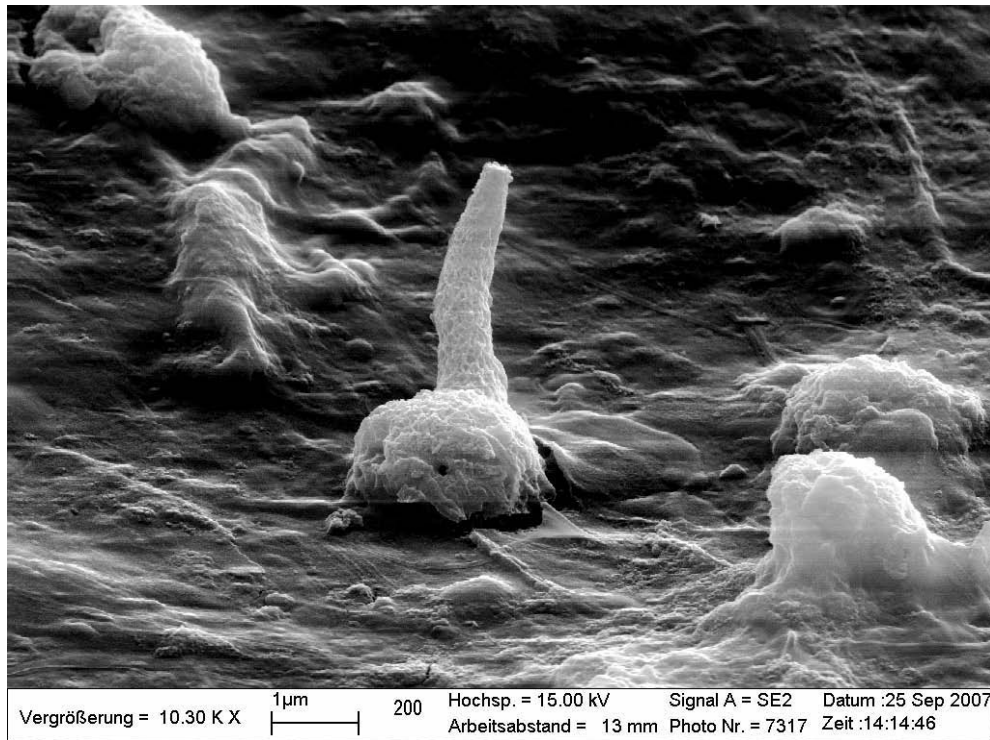
By scanning electron microscopy, typical structures have been identified as iron deposits by elemental analysis using electron dispersive x-ray (EDX). The microbial structures have been visible in the layer of the membrane samples “before cleaning” and “after cleaning” (Fig. 5). It was suggested that they may have played an important role in building the fouling layer. This suggestion could be positively verified by cultivation using specific agar media. Living manganese-oxidising bacteria were present up to several thousands cfu/cm² before cleaning and only a few after cleaning.

Fig. 5. Deposit on the membrane after cleaning showing the same type of structure originated from iron-oxidising bacteria but slightly “damaged” compared to the ones before cleaning; the elemental composition showed iron but no manganese-oxidising bacteria.

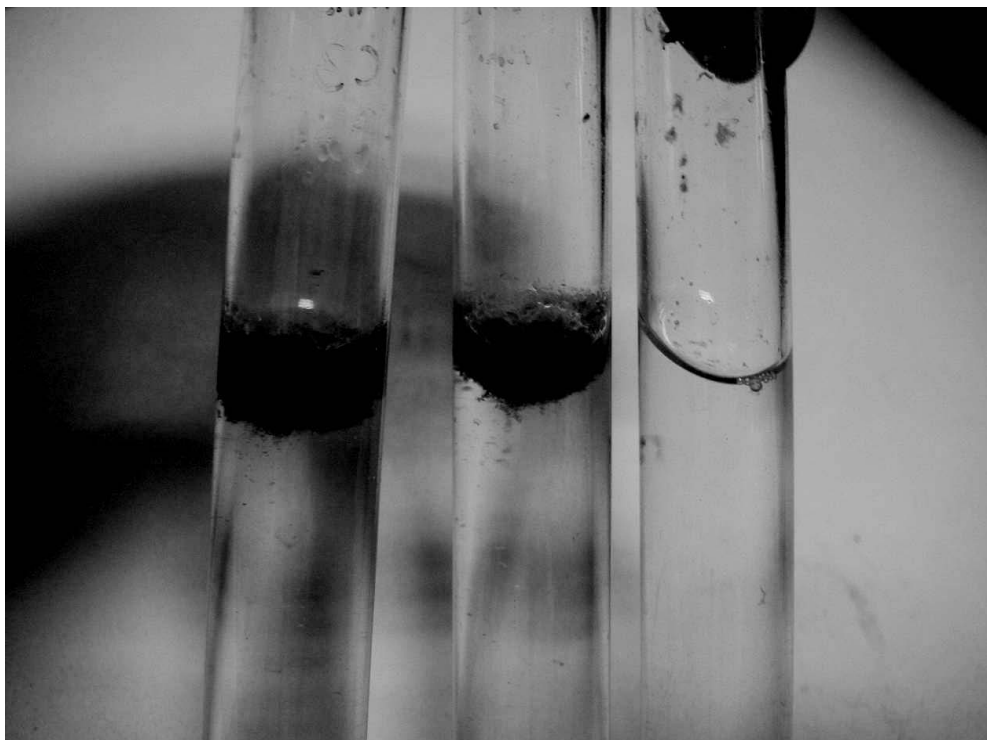
Methods for enumeration of iron-oxidising bacteria have been published for many years and it is known that enumeration of iron-oxidising bacteria may be confronted with the contamination of fungi [2]. A three tube Multiple Number Assay (MPN) based on cultivation in a liquid special media was performed with dilution levels ranging from 10^0 to 10^{-6} using the layer sample “after cleaning”. The formation of a red coloured band at the water/air interface indicated the presence of iron-oxidising bacteria (Fig. 6). The results for the deposit of the sample “after

Fig. 6. Image of the water/air interface of the three MPN tubes with dilution level 0 using the media for enumeration of iron-oxidising bacteria.

cleaning” indicated a low level of iron-oxidising bacteria with a few hundreds per square centimetre. This is not in contrast to the microscopic observation because cultivation requires living cells. Cleaning may have killed a lot of the bacteria but not removed their metabolite products. The presence of a lot of biological originated structures as shown in the SEM pictures (Figs 7, 5) indicated a lot of iron-oxidising bacteria: Element composition of an area with typical biological structures is shown in Fig. 8.

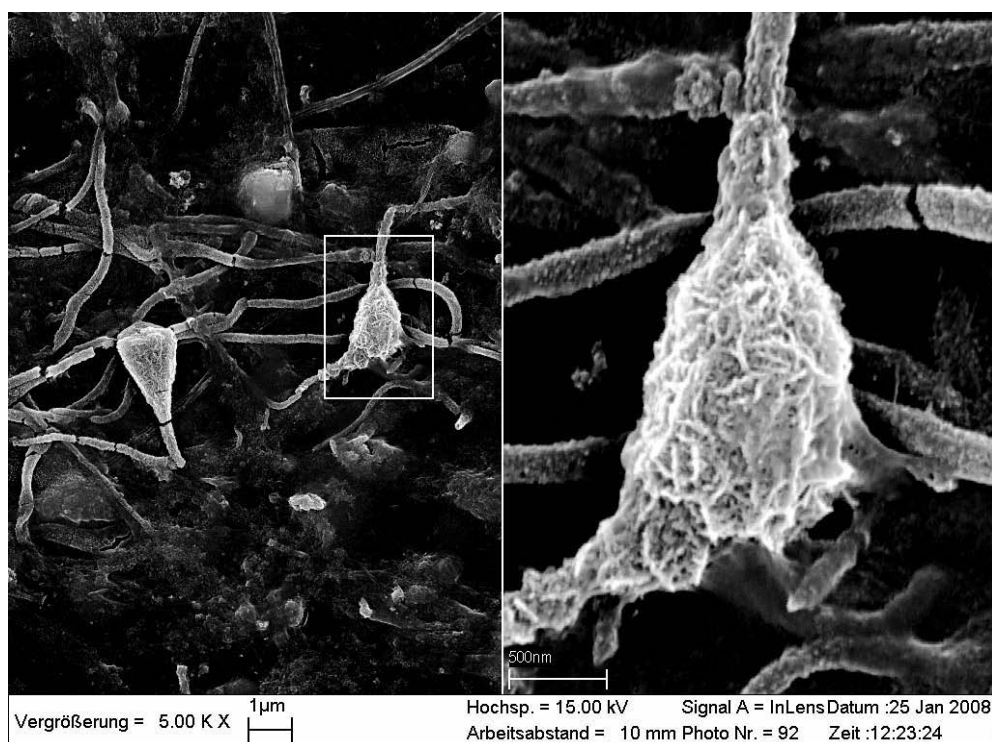
Fig. 7. SEM picture of typical structure (manganese-oxidising bacteria) on the deposit surface before cleaning.

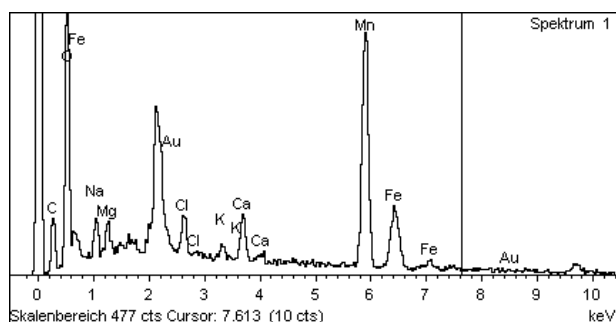
Fig. 8. Element composition of an area with typical biological structures ($4 \mu\text{m}^2$) as shown above in Figure 7.
