An overview of the localized corrosion problems in seawater desalination plants – Some recent case studies

Anees U. Malik*, Ismaeel Andijani, M. Mobin, Saleh Al-Fozan, Fahd Al-Muaili, Mohammad Al-Hajiri

*Saline Water Desalination Research Institute (SWDRI), Saline Water Conversion Corporation (SWCC), P.O. Box 8328, Al-Jubail 31951, Saudi Arabia
Tel. +966 (3) 343-3477; Fax +966 (3) 343-1615; email: malikanees@hotmail.com, rdc@swcc.gov.sa*

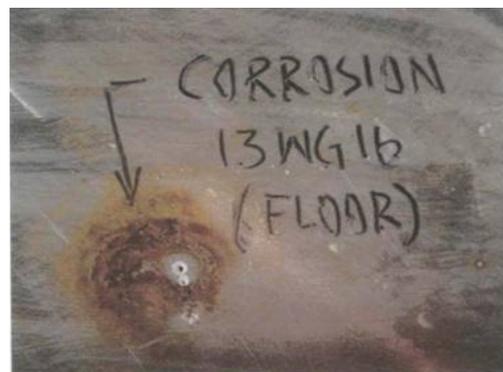
The evaporator has 16 stages (cells) in which first 13 are heat recovery and the last 3 are heat rejection stages. The flash chamber plates were made of carbon steel with AISI 317 SS internal cladding. Approximately 4 years after the plant was commissioned, indication of corrosion processes in the form of numerous red-colored spots was noticed on the floor plates of stages 11–16. Upon cleaning the red spots, pits were found in the middle of the spots with slightly wet outer surfaces (Fig. 1).

The results of investigations based on NDT, metallography, SEM and EDX techniques indicate damage to the floor plates due to localized corrosion. The incomplete drainage of high chloride water from stages 11–16 floor plates during shut down (Fig. 2) resulted in a fairly long period of stagnancy which produced conditions favorable to pitting corrosion of austenitic stainless steel. The SEM picture of the corrosion products inside the pit show cluster of porous materials mainly comprised of NaCl in very high concentration and SiO₂ and Al₂O₃ in very small amounts as revealed by EDX studies (Fig. 3). The absence

Fig. 1. Corrosion spots after grinding to 1 mm depth.

It was recommended that the design of the flash chamber cells should be reviewed with special reference to the floor levels 1–10 and 11–16. Also, the provision of additional drain between chambers 11–15 should be made.

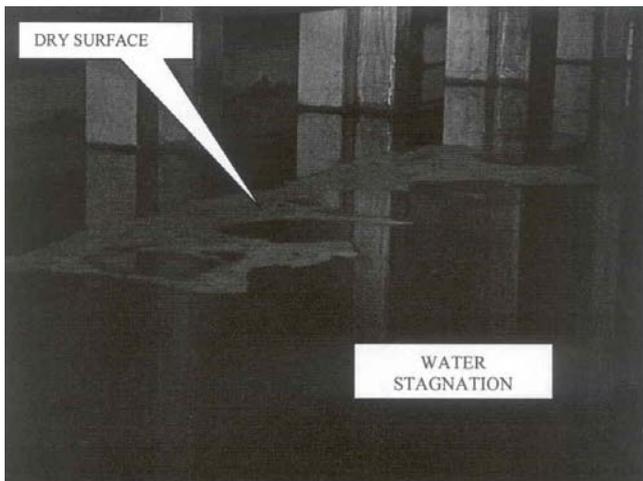
Fig. 2. Desalination Line 13, water stagnation in Cell 14, bottom floor.

of drainage has been attributed to uneven level of floor plates of different stages of the desal unit.

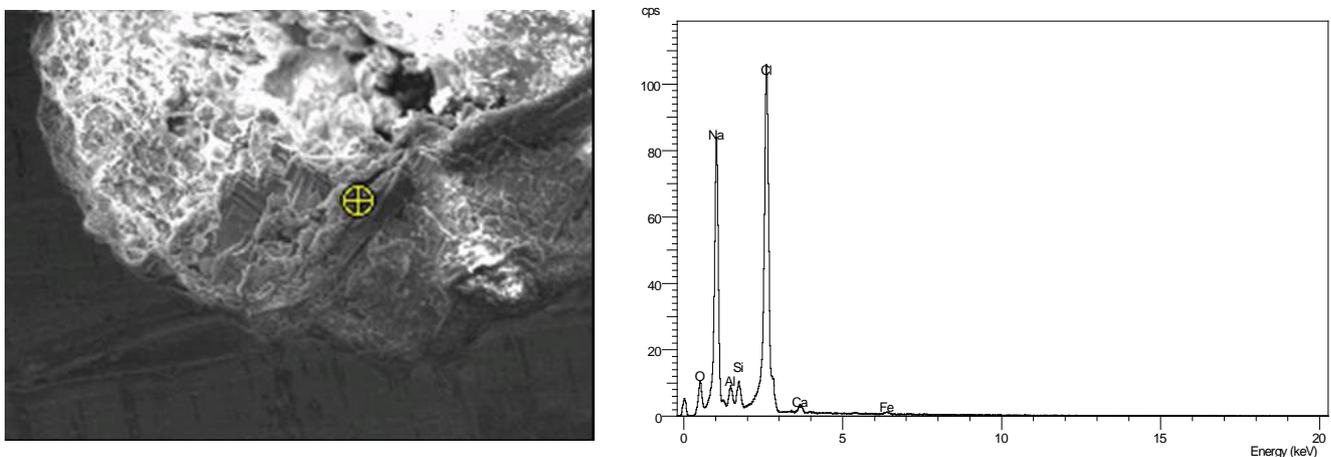
Fig. 3. SEM picture and EDX profile of the corrosion products (inside the pit).

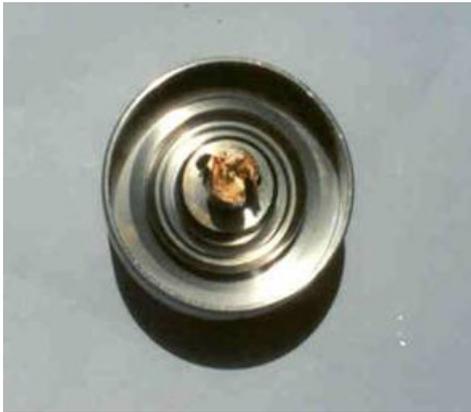
The local attack brought about the crevice corrosion appearing to be the cause of failure of the cartridge filter.

- (i) Pits on the surface of the bottom cap (Fig. 4).
- (ii) The presence of thick deposits of corrosion products at the threadings of the bottom cap (Fig. 5) which are rich in chloride as evidenced by the EDX spectrum (Fig.6), which shows strong peak of the chloride.
- (iii) The SEM image of corroded cartridge filter shows the presence of aggregates of dark brown powdery like products (Fig. 6).
- (iv) The corrosion marks on the stud, bottom face of the flange, O-ring slots, threadings of embedded nuts and hexagonal nuts.

Fig. 4. Bottom of micron cartridge filter cap showing reddish brown corrosion products at the center.

It was recommended to use either a superaustenitic stainless steel or a suitable polymeric material for preventing the possibility of localized attack in MCF.

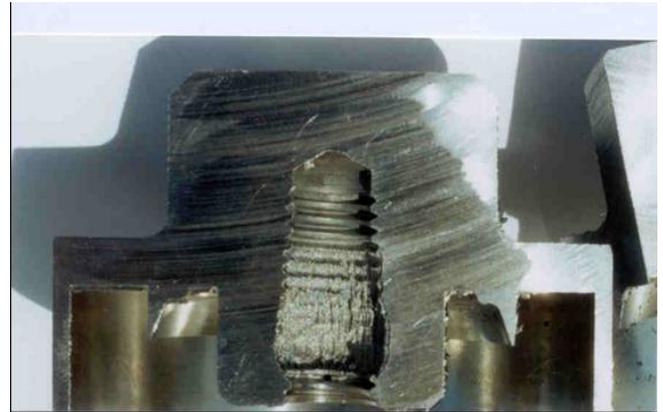
Fig. 5. Corrosion product deposits on the threading (female) due to crevice corrosion.

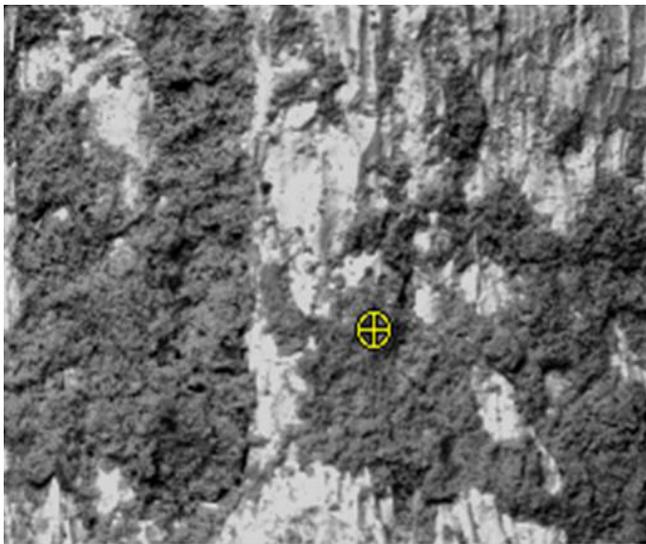
Fig. 6. EDX profile of the corrosion products on stud thread of the micron cartridge filter.

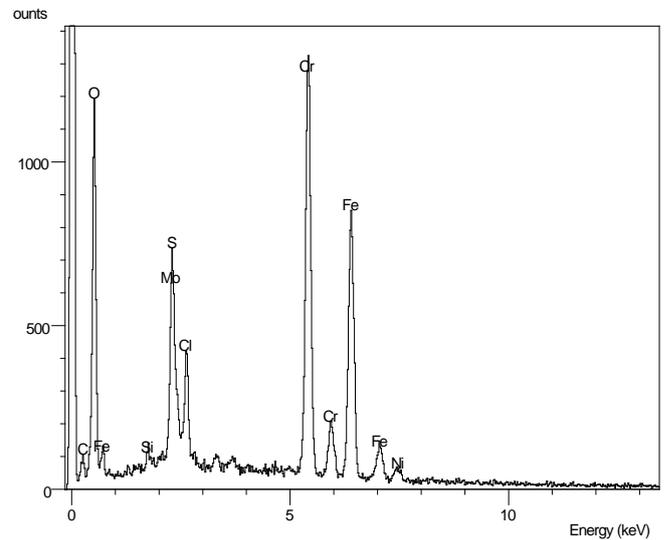
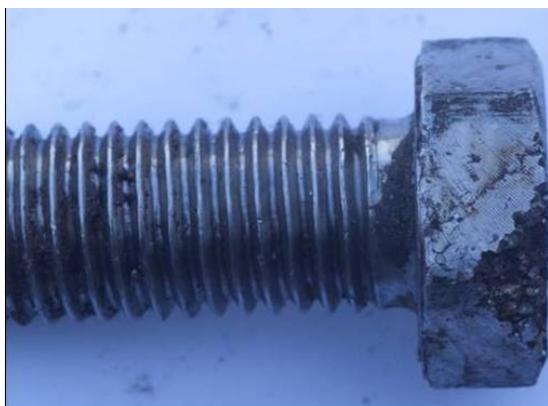
The bolts were found cracked during the disassembly of the unit of a desal pump (Figs. 7 and 8). The bolts were used to hold the bearing spider with lower and upper column pipe. The pump was partially submerged in seawater and the bolts remained submerged completely. The bolts were made of duplex 1.4460 and had been in use for more than 10 years. The nuts of the bolts were made of duplex 1.4462 and indicated no corrosion.

The bolts might have corroded at the crevices by local attack for long periods of time under seawater immersion conditions. This along with stresses also initiated corrosion fatigue (Fig. 9). The duplex steel material was corroded by local attack under the influence of several factors, namely, the availability of many crevice sites in the bolt, coarsened structure of the alloy matrix (Fig. 10) and long exposure to seawater. For bolts subjected to long exposure of seawater in presence of crevices and under

Fig. 7. Photograph showing the surface of the head of the failed bolt.

dynamic stress conditions, it was recommended to use superduplex with higher Mo content (>3%) along with nitrogen additions.

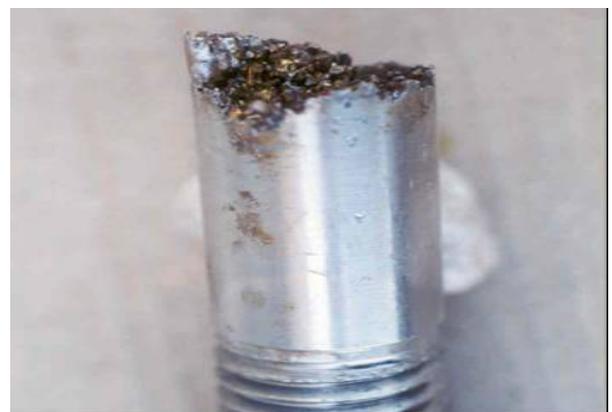
Fig. 8. Photograph showing fracture mode of the bolt at the metal surface near the bolt head showing regions of depression and protrusion.

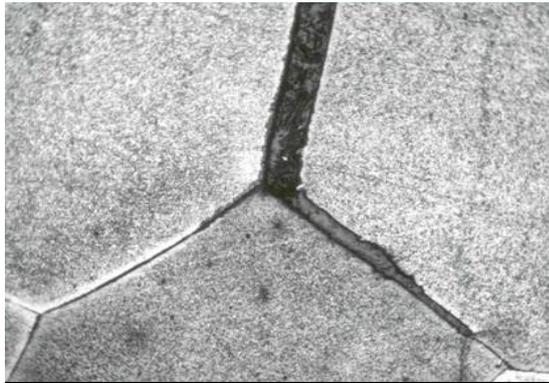
Fig. 9. Photomicrograph of the cross-section of the failed bolt showing initiation of an intergranular crack 100 ×.

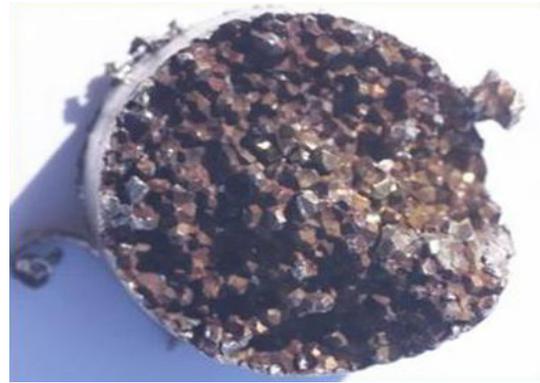
Fig. 10. Photograph showing fracture surface having coarse granular texture with brownish red crystalloids.

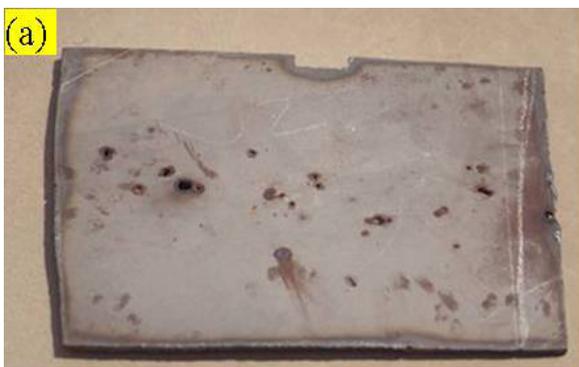
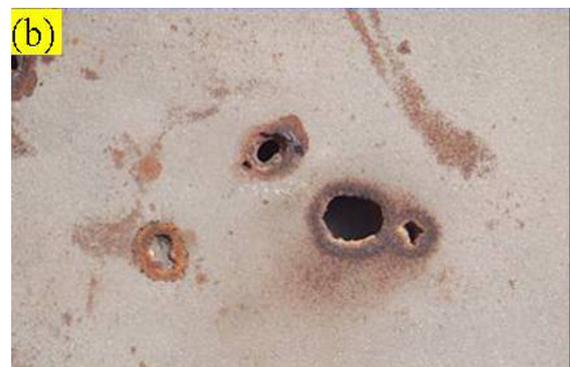
The presence of holes and deep pitting in the bottom plate of a potable water storage tank was reported (Fig. 11). The tank bottom plate had been in contact with 2 different corroding environments, i.e., potable water in the inner side and soil on the outer side. The inner surface was protected against corrosion by a combination of epoxy coating and CP whereas the outer surface was protected by a layer of asphalt and C.P. A study of the samples of failed bottom plate and magnetic flux leakage (MFL) report show severe underside and water side corrosion with possibility of simultaneous initiation of the localized process at both the sides.

The blistering in the coating might be due to malfunctioning of C.P. system. The heavy underside (soil side) corrosion was initiated possibly due to stray DC from impressed C.P. system operating on other tanks in the vicinity. The contact of leaked potable water from inside the tank through holes with underside plates further contributed in accelerating the underside corrosion.

Fig. 11. (a) Inner surface of the bottom plate, cut from a location near the annular plate, in the as received condition (b) A close-up view of the hole and pit.

It was recommended to install an integrated CP for all the tanks which could eliminate the possible effect of stray DC.

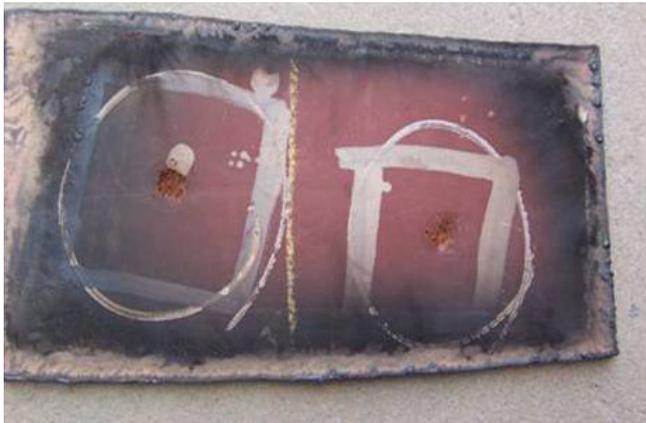
The water wide corrosion was initiated as a result of blistering in the epoxy coating which led to the localized attack and resulted in pitting and holes (Figs. 12 and 13).

Fig. 12. Inner surface of the bottom plate cut from a location away from annular plate showing only pits

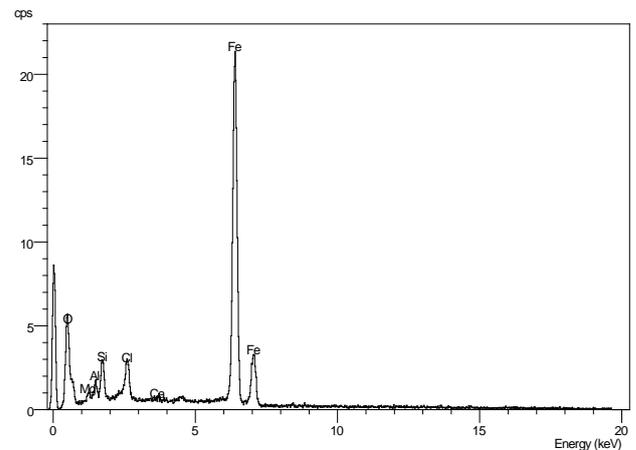
Fig. 13. EDX profile of the corrosion products on the surface of the pit.

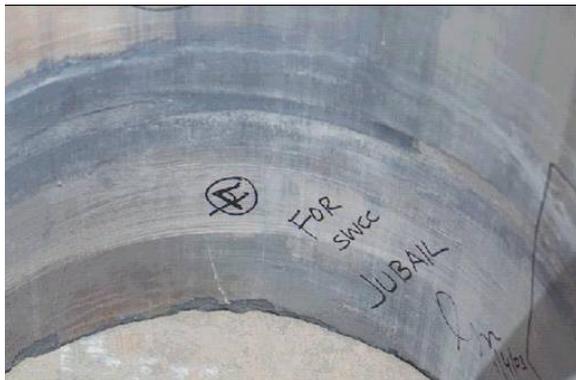
Fig. 14. Photograph of internal of pipe sample 4 showing sound pipe.

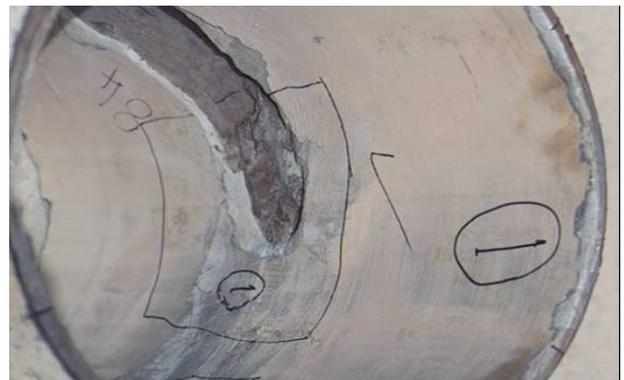
Fig. 15. Photograph of internal of pipe sample 1 showing disbondment of X-Pando sealant.

The main cause of pipe failure appears to be deterioration or disbondment of X-Pando by the high chloride-sulfate water. This resulted in exposure of the metal to water and in consequence, initiation and subsequent propagation of localized corrosion in the internal of pipe. As the performance of the X-Pando was unsatisfactory at the joints, it was recommended to remove it and replace by a suitable sealant.

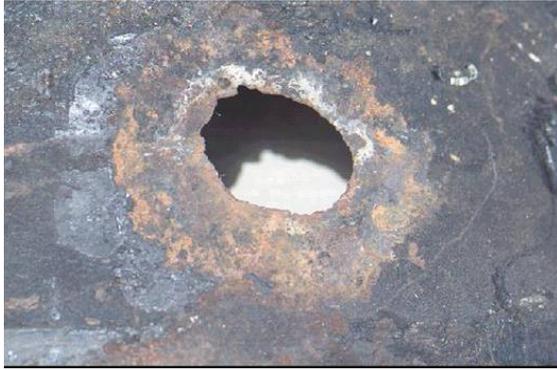
Visible examination of the pipe, EDX analysis and SEM studies of the pieces from the pipe indicate severe corrosion and the presence of cracks and holes in the internal of pipes (Fig. 16). The EDX of the region around the hole showed presence of Ca and Cl⁻ besides Fe ((Fig. 17).

Fig. 16. Close-up photograph of the external of pipe 1 showing a hole in the metal.

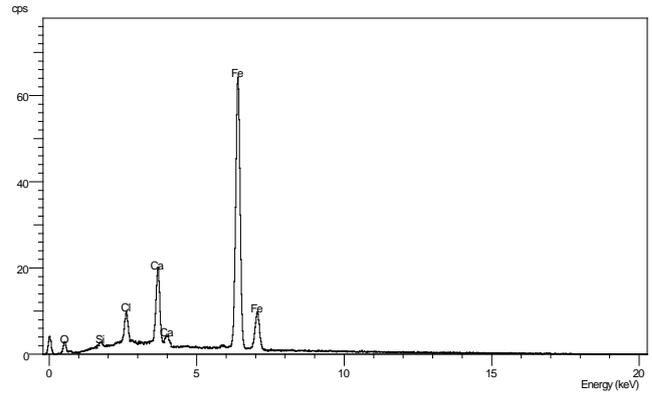
Fig. 17. EDX profile of the damaged area in internal pipe 1.

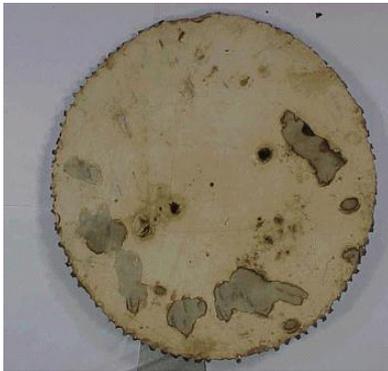
Corrosion of a repainted epoxy coating over the inner side of the bottom plate of a fuel oil tank, in a desalination and power plant, was reported (Fig. 18). This resulted in the perforation of the bottom plate. According to the report, some cavities and minute pits were already existed on the inner surface of the plate when coating was reapplied but the painters ignored them. After 2 months of service following repairs, penetration of the bottom plate occurred.

The cavities and pits already present on the inner side of the bottom plate of the tank were caused by localized corrosion attack that stemmed from the failure of the original epoxy coating from its long exposure to crude oil (Fig. 19). The failure of repainted coating and subsequent perforation of the plate was again due to localized attack

Fig. 18. Photograph of plate sample in as received condition.

It was recommended that in order to avoid failure, chloride decontamination by chemical treatment should be considered as an essential step before repainting. A phosphoric acid based treatment is reported to be effective in such cases.

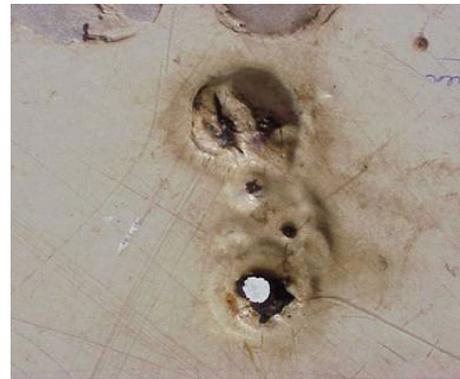
Fig. 19. Photograph showing a large hole in the plate sample.

which was initiated by the chloride and other impurities in the pits and cavities underneath the repainted coating. The presence of chloride and impurities (Si, Mg, Al, K, Ca, Ti and Fe compounds) is indicated by the EDX profile of the corrosion products in the pits (Fig. 20). The SEM image of the corrosion products in the pit indicates the presence of agglomeration of different materials.

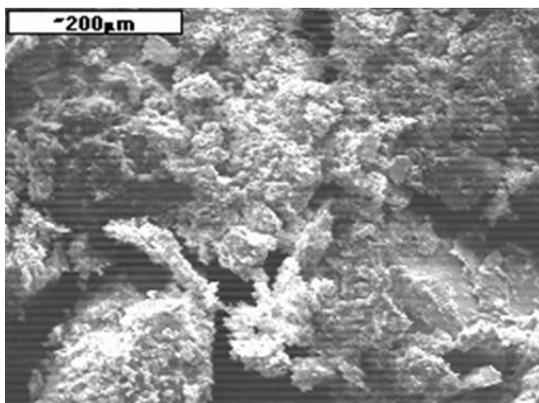
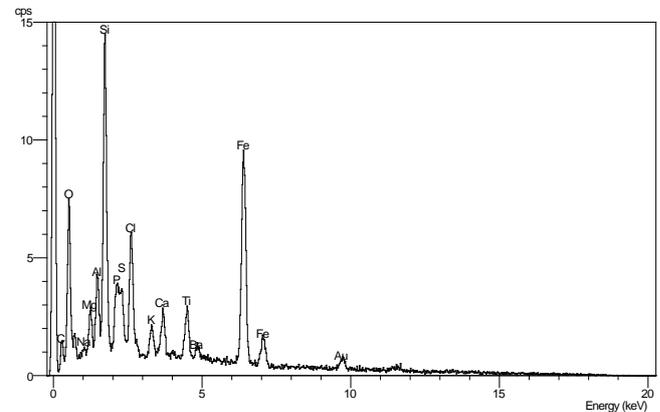
Fig. 20. EDX profile of corrosion products collected from the pits on the plate.

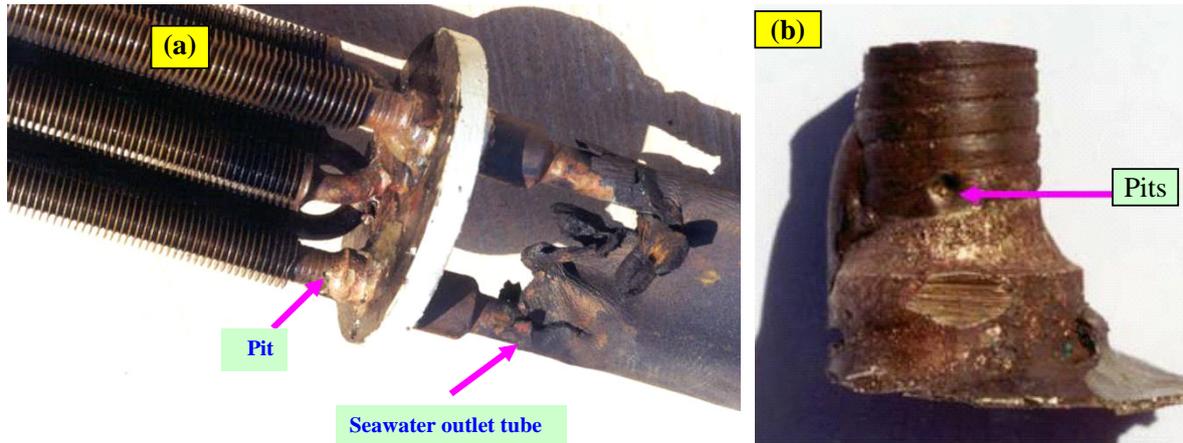
Fig. 21. Photographs of failed oil cooler showing macropits.

Failure was reported of a cupronickel cooling coil tube in the main bearing oil cooler of a pump in a SWRO plant (Fig. 21). Failure appeared in the form of pitting at the outlet of the cooling coil tube. The cooling medium was aerated seawater.

The results of the investigation led to the conclusion that the cause of the failure could be attributed to localized pitting from the synergic action of a combination of factors, namely, stagnancy, welding heat affected zone (HAZ), the presence of high chloride and sulfates in seawater and induction of subsequent stresses.

It was recommended to carry out tests for soundness of the welding and to adopt measures for keeping the flow path free from foreign obstacles.

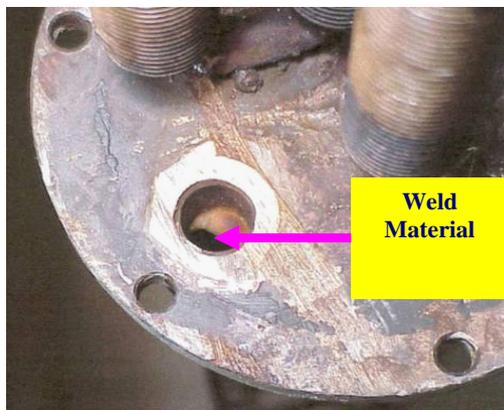
Low or near stagnant velocity or the flow of seawater appeared to be the key factor in bringing about the failure. The metallographic and SEM studies indicate that obstructions in the flow path were mainly due to improper welding (Fig. 22).

Fig. 22. Photograph showing the obstruction in the flow path at the flange due to defective welding.

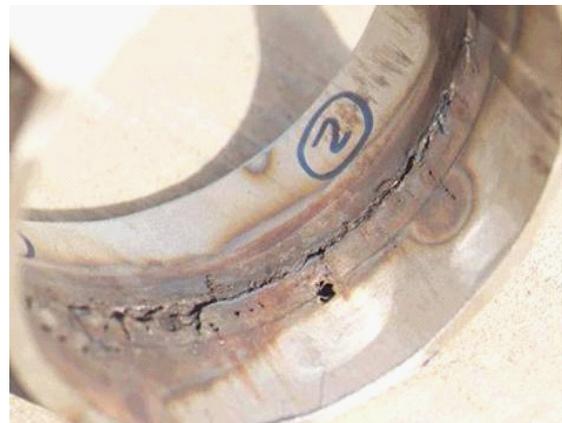
Leakages were reported at different locations in the weld joints of brine rejection in a 4325 m³/h SWRO plant (Fig. 23).

The pipes, main headers, HP pumps and weld joints were made of AISI 317L SS. Before commissioning, the SWRO plant was under preservation and membranes were preserved using formalin. The pipes showed severe corrosion at the weld joints. The corrosion failure appeared to occur due to long preservation in high salinity water containing formalin which made the water acidic. The stagnancy in water promoted the on set of localized

Fig. 23. Photograph of pipe 2 (internal view) showing corrosion at the welding holes. Pits and cleavages can be seen.

The existing weld joint, exhibited poor performance due to inadequate corrosion resistance to brine can be replaced by tig weld using Inconel 625 welding rods. The latter appeared to provide sound weld.

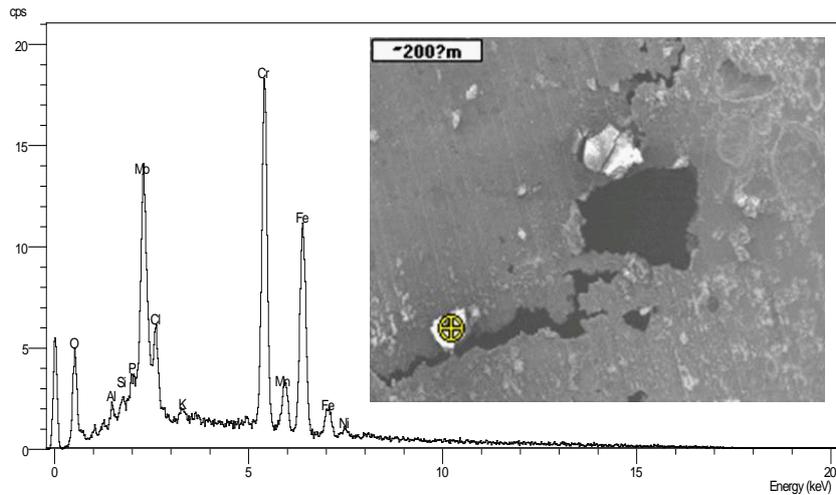
Fig. 24. SEM picture of the weld area in sample 1A shows the presence of small and big pits all over the surface. Emanation of the crack can also be seen.

corrosion in 317 SS material which resulted in the formation of pits and subsequently initiation and propagation of corrosion process (Fig. 24).

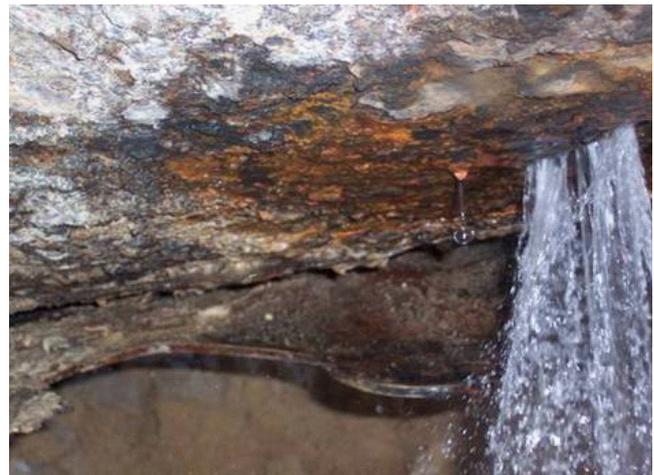
The pipe was found ruptured at 6 o'clock positions away from the joints. The pipe was found to be severely corroded at or around the leakage point from which water was flowing out profusely (Fig. 25). The P.E. coating around the leakage appeared to be disbonded exposing the bare steel surface. The different steps involved during the failure are:

Fig. 25. Photograph showing gushing of the water from the leaked pipeline.

It is recommended to rejuvenate the CP system of pipeline.

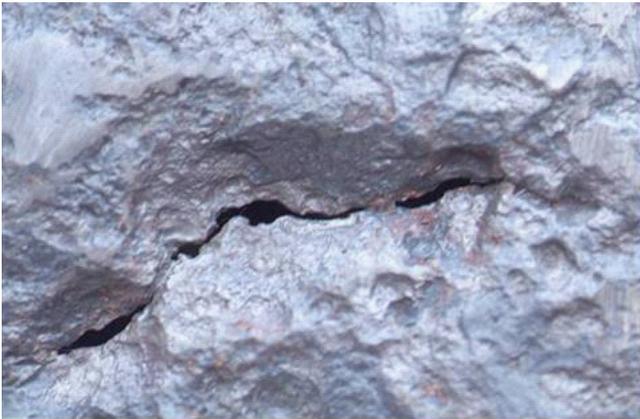
- Dismemberment of external P.E. coating left bare steel. Surface of the pipe exposed to highly corrosive soil.
- Steel in contact with corrosive soil at 6 o'clock position initiated corrosion on the external side. Subsequently, the process of corrosion propagation progressed for a long time (Fig. 26).
- The corrosion of steel pipe resulted in localized thinning of the wall of the pipe and subsequent rupture of the pipe.

Fig. 26. Photograph showing close-up of the rupture site.

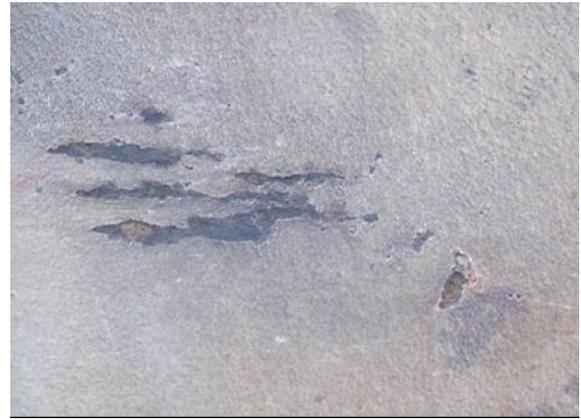
- The pits on the water side were formed near or far away from the rupture as a result of localized removal of cement lining (Fig. 27).
- These pits could act as the precursor for rupture which would occur in future at other locations.

Fig. 27. Photograph of the inner surface of the pipe section showing presence of pits of various dimensions.

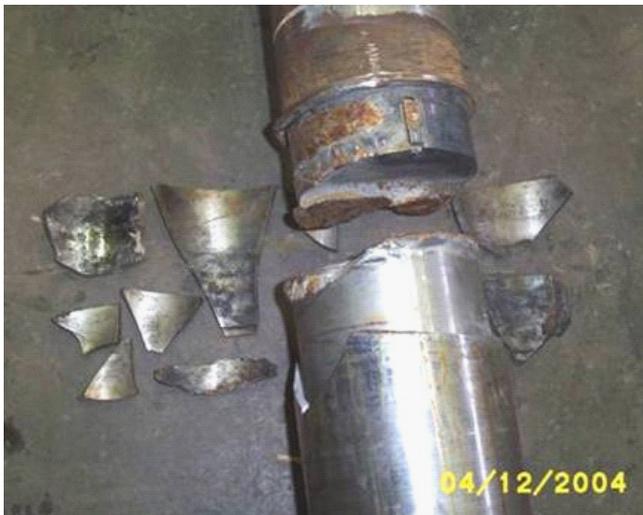
Shearing of a shaft in a brine recycle pump was reported (Fig. 28). Failure of shaft, discharge column pipe,

Fig. 28. Closer view of first rupture in the shaft.

The corrosion would have been initiated during the operation and/or during long or short shut down. The crack initiation was located in the bearing key area which is classified as crevice. The keys are used to make the joint assembly between the shaft and coupling of the driving motor. The ingress of the chloride into the crevice of the key slot recess caused intense localized corrosion in this area giving rise to stress concentration sites for crack initiation (Fig. 31). Also, the rotational stress could have contributed in crack propagation which ultimately resulted in failure by corrosion fatigue.

1. Remedial action should be taken for eliminating any chances of chloride ingress inside the key recess. This may require design modification of the assembly between the shaft and the coupling.

2. All brine recycle pumps must be inspected by dye penetration test (DPT) during routine maintenance.

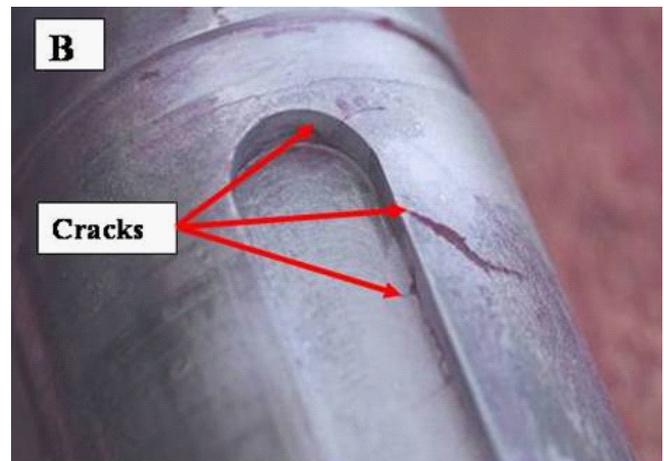
Fig. 29. Cracks location on shaft key area.

Visual inspection of the pump showed many cracks at different locations especially at the key (Fig. 29). Also some pits were found on the shaft surface. The SEM of the pit on the shaft surface shows the presence of a multi phase structure in which white particulates of non-metallic constituents (mainly Ca and Si compounds) are presumably present in a iron-rich dark grey matrix (Fig. 30). EDX analysis shows chloride ions in the pits indicating initiation of cracks in the shaft area (Fig. 30).

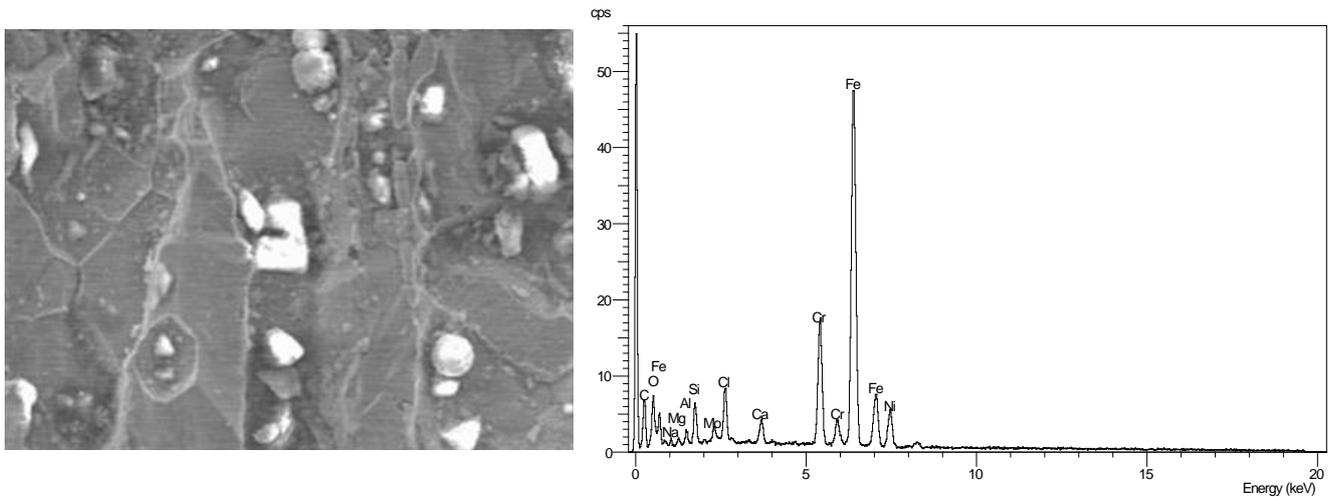
Fig. 30. EDX profile of pit on the shaft surface.

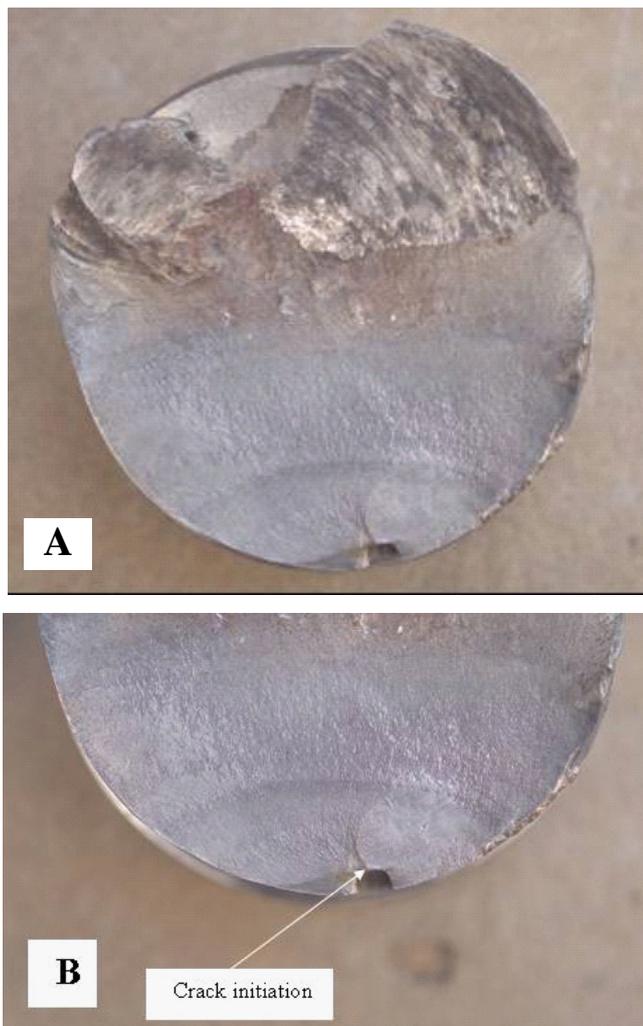
Fig. 31. Closer views (A and B) of a face of the fractured shaft.
