Investigation studies of vapor side corrosion in a multistage flash desalination pilot plant

A. Al-Arifia*, I.S. Al-Mutaz^b, M.A. Alodan^b, F. Abudaleem^b

ABSTRACT

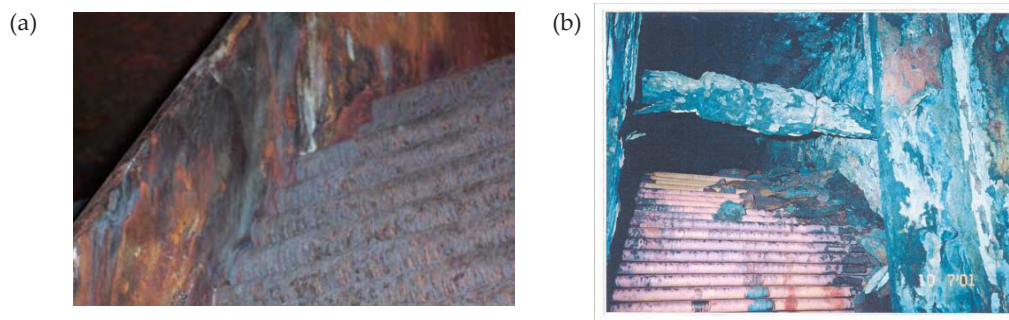
Fig. 1. VSC in MSF plant: (a) Non-lining area above the demister of the partition plate; (b) Vapor side corrosion of Cu-Ni tubes.

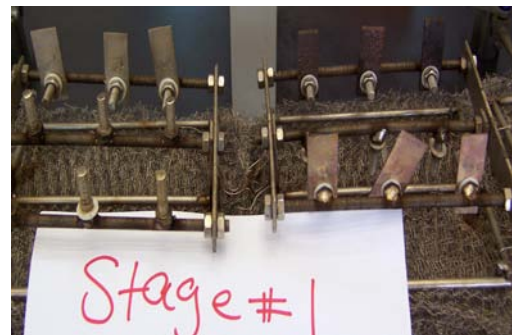
Fig. 5. Appearance of the Cu-Ni alloys at the end of the test at 90°C (TBT) at stage one.

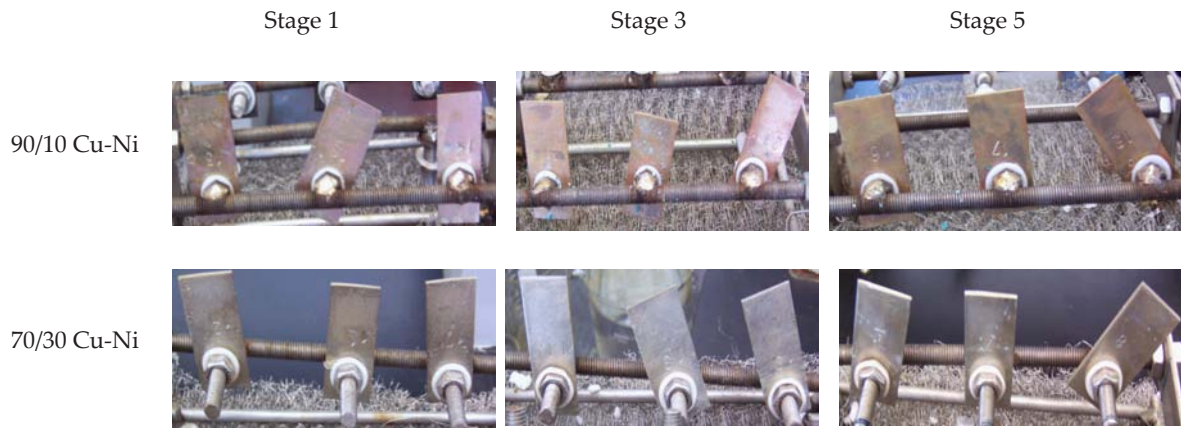
Fig. 6. Appearance of 90/10 Cu-Ni and 70/30 Cu-Ni after the conclusion of the test for stage one, stage three and stage five at 90°C (TBT) in the MSF pilot plant.

positioned alloy formed thicker scales. The oxide scales on cupronickel (90/10 and 70/30 Cu-Ni) at 90°C have similar morphologies at all the three stages, 90/10 Cu-Ni forms dark to light brown cupric oxide deposits, 70/30 Cu-Ni oxide scales are light and have invariably green products inclusion presumably cupric oxide along with copper basic carbonate.

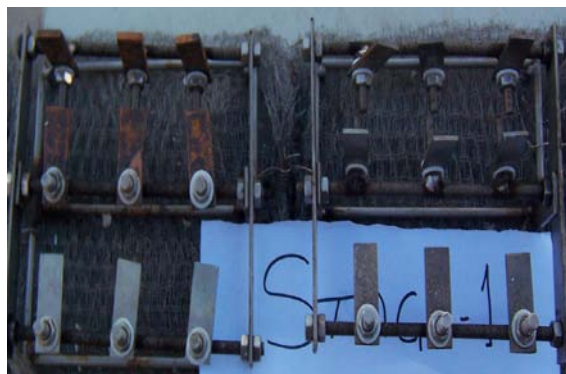
Fig. 7 shows the appearance of coupons immediately after the test completion at 100°C (TBT) and before removal of the coupons from the holder in stage one. Fig. 8

Fig. 7. The photograph shows the appearance of coupons after the test completion at 100°C (TBT) at stage one.

At 100°C, 90/10 cupronickel coupons show brown CuO scales. In 70/30 Cu-Ni, green products which are presumably of Ni oxide and/or copper basic carbonate appeared along with brown cupric oxide.

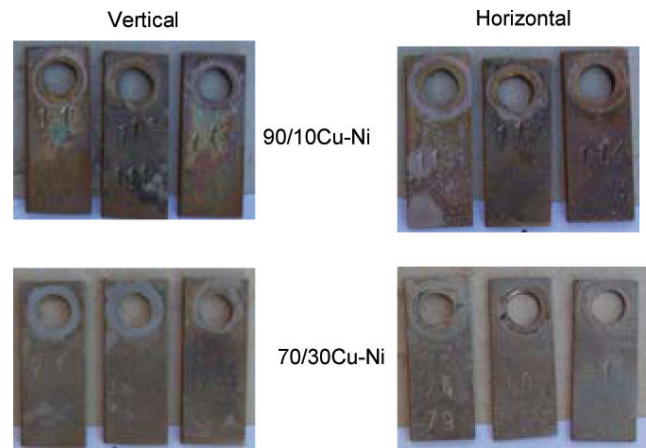
shows a close look on the coupons individually in vertical and horizontal positions for stage one. Table 5 gives the corrosion rate for the coupons in stage one at 100°C (TBT) in the two positions (vertical and horizontal).

Fig. 8. Appearance of coupons in stage one in vertical and horizontal positions at temperature 100°C (TBT).

At 100°C (TBT) horizontal and vertical coupons were used. In stage one and stage five, Cu-Ni, 90/10 has higher corrosion rate in the vertical position compared with the horizontal one. For Cu-Ni, 70/30 the opposite behavior is observed except for stage five. The higher corrosion rates in horizontal position have been attributed to the exposure of the vapor phase to a much higher surface area. A glance on the corrosion rate values of the coupons at the vertical and horizontal positions points out that the differences are very small. Whilst the corrosion rates in stage three are higher in the horizontal position, in stage five, higher corrosion rates in vertical position. At 100°C (TBT), in stage three the corrosion rates of 90/10 Cu-Ni and 70/30 Cu-Ni are similar at both positions.

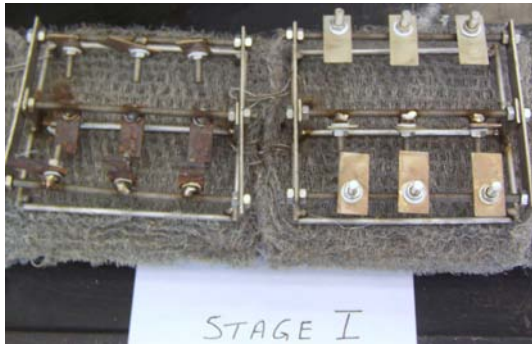
Fig. 9 shows the appearance of coupons immediately

Fig. 9. Appearance of coupons immediately after the completion of the test at 110°C (TBT) at stage one.

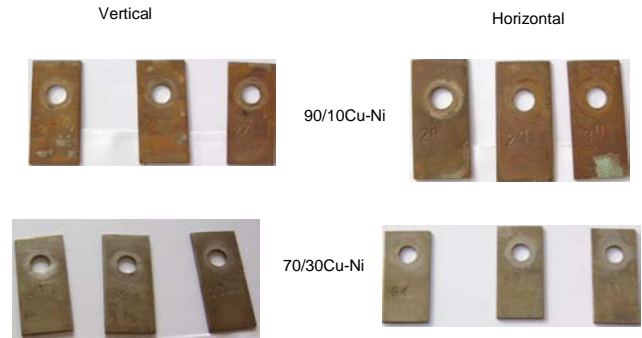
after the test completion and before removal of the coupons from the holder in stage one. Fig. 10 shows a close look of the coupons individually. Table 6 provides corrosion rates at the end of the test at 110°C (TBT) for stage one, three and five in vertical and horizontal positions respectively. Figs. 11 and 12 show the SEM pictures and EDX spectra for the Cu-Ni (90/10 and 70/30) respectively after exposure to this temperature.

Fig. 10. Appearance of coupons in vertical and horizontal positions immediately after the completion of the test at 110°C (TBT) at stage one.

corrosion rate of 90/10 Cu-Ni in the horizontal positions is higher than in the vertical position, for 70/30 Cu-Ni, the behavior is opposite although the difference in corrosion rates is marginal. In stage three, the corrosion rates of alloys at 110°C, in vertical position are invariably lower than for horizontally positioned alloys. In stage five, 110°C, the corrosion rates in horizontal position for 90/10 Cu-Ni are lower than in vertical positions. For 70/30 Cu-Ni, the corrosion rates of vertical and horizontal positions are very low and have almost the same value.

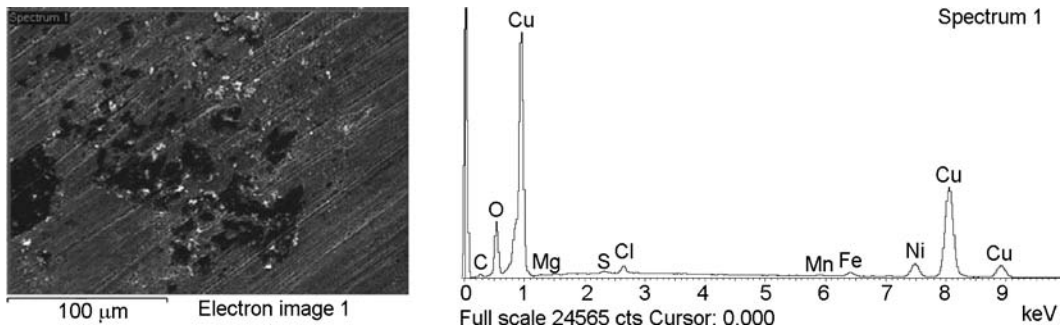
Fig. 11. (a) SEM picture; (b) EDX spectrum of the oxide scales for the 90/10 Cu-Ni coupons in stage one at 110°C (TBT).

At 110°C, in stage one, in 90/10 Cu-Ni alloys, the scales are brownish along with greenish products at some locations. In 70/30 Cu-Ni, the scales are relatively thin. The SEM and EDX studies on the corrosion products formed on cupronickel alloys after exposure to vapor side show the presence of copper oxide in predominant concentration. In case of 90/10 Cu-Ni alloy, Ni is present in an extremely low concentration (Fig. 11b) but in 70/30 Cu-Ni alloy, NiO is present in a much higher concentration (Fig. 12b). At 119°C, 90/10 Cu-Ni alloy shows layered scales containing copper oxide with high concentration of Cl perhaps in the form of Mg chloride. There is no perceptible presence of Ni. The scales formed on 70/30 Cu-Ni alloy at 119°C are generally uniform but disrupted at some locations as indicated by the SEM picture. The morphology of the scales indicates the presence of NiO and CuO with inclusions of chloride of Ca and Mg. The EDX profile shows strong peaks of Ni, Cu and O and moderately strong peak of Cl.

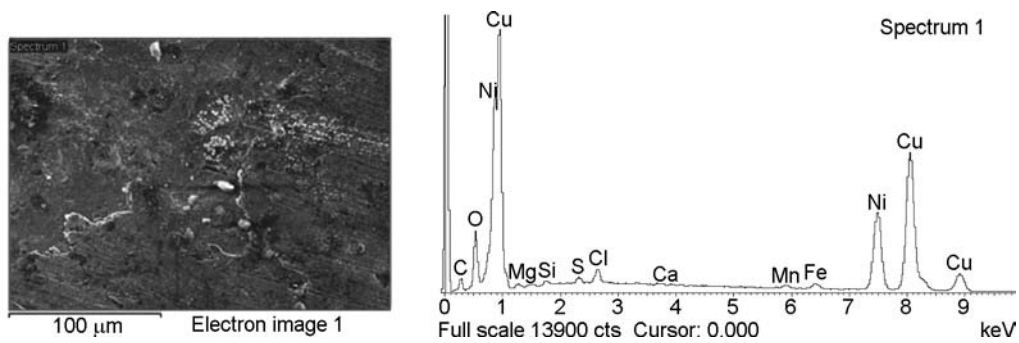
Fig. 12. (a) SEM picture; (b) EDX spectrum of the oxide scales for the 70/30 Cu-Ni coupons in stage one at 110°C (TBT).

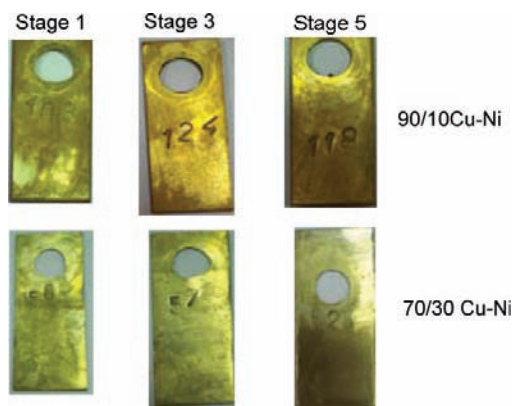
Fig. 13 shows a close look of the appearance of coupons immediately after the test completion individually in stage one, three and five. The corrosion rates at these stages are shown in Table 7. Figs. 14 and 15 show the SEM picture and EDX profile for the Cu-Ni (90/10 and 70/30) respectively after exposure to this temperature.

Fig. 13. Appearance of coupons immediately after the completion of the test at 119°C (TBT) at stage one, three and five.

In 119°C (TBT) test, stage one, the corrosion rates for 90/10 Cu-Ni and 70/30 Cu-Ni are 0.25, and 0.049 mpy, respectively. In stage three the corrosion rates of the two alloys are lower than those in stage one. The corrosion rates of 90/10 Cu-Ni are about one order of magnitude higher than 70/30 Cu-Ni. At 119°C, stage five, the corrosion rates of cupronickel alloys are lower than in stages one and three.

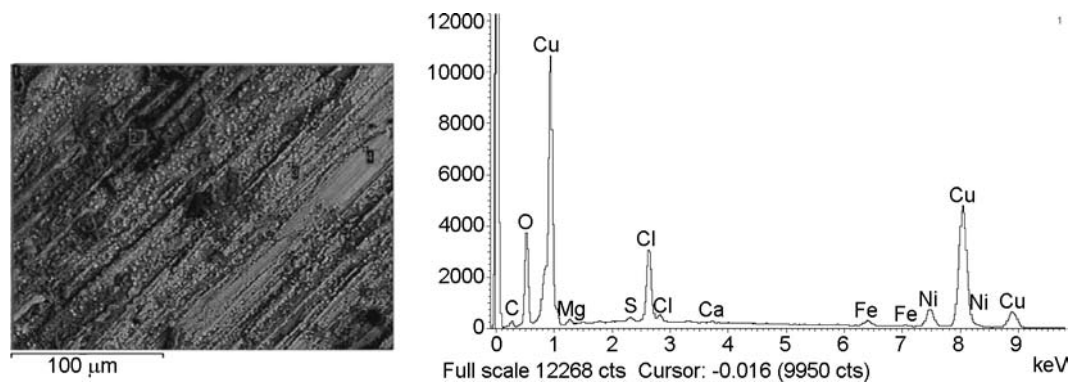
Fig. 14. (a) SEM picture; (b) EDX spectrum of the oxide scales for the 90/10 Cu-Ni coupons in stage one at 119°C (TBT).

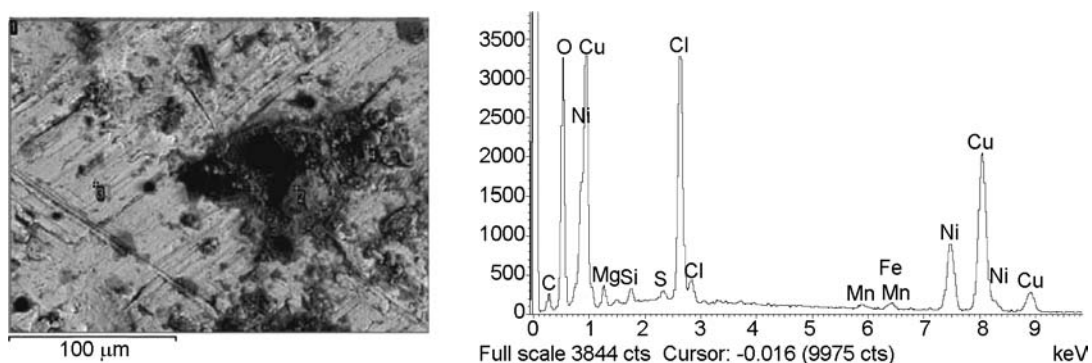
Fig. 15. (a) SEM picture; (b) EDX spectrum of the oxide scales for the 70/30 Cu-Ni coupons in stage one at 119°C (TBT).

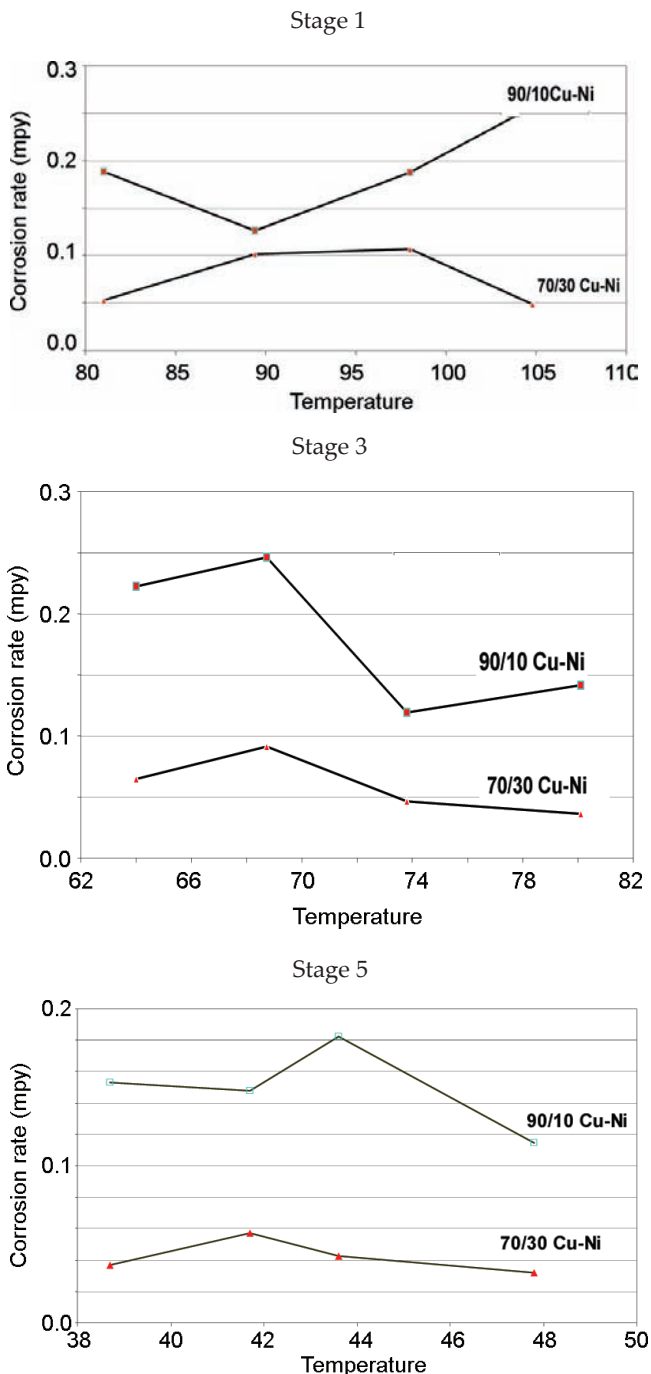
Fig. 16 shows the relation of vapor zone temperature with the corrosion rate for the coupons at stage one, three

Fig. 16. Corrosion rate for coupons at stage one, three and five in MSF pilot plant at different vapor zone temperatures.

and five in the MSF pilot plant at the four temperatures. It is obvious from this figure that there is irregular behavior of temperature with corrosion of copper nickel alloys.
