Investigation of SWRO membrane failures of two different configurations

A. Mohammed Farooque

Desalination Technologies Research Institute (DTRI), Saline Water Conversion Corporation (SWCC), P.O.Box 8328, Al-Jubail, Saudi Arabia, email: rdc@swcc.gov.sa

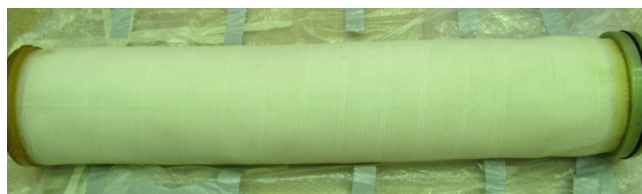
with pH of 4 adjusted by adding ammonium hydroxide was used for chemical cleaning. Upon inspection, the membrane was found to be free from any visible defects (Fig. 1). Moreover, the outer fibers of the membrane was found to be very clean free from deposits and looked like new (Fig. 2).

Fig. 1. A view of CTA HFF SWRO membrane before dissection.

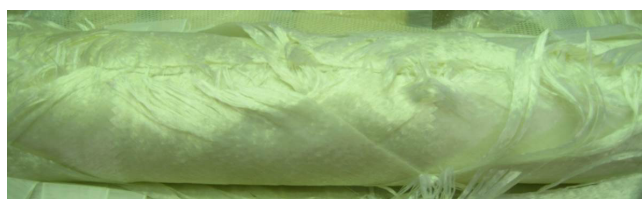
Fig. 2. A closer view of membrane showing very clean outer fibers.

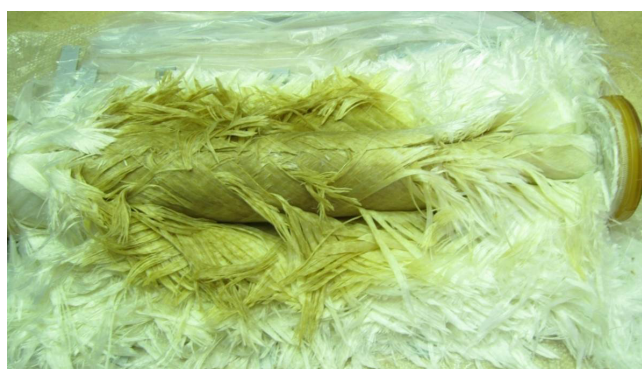
However, the fibers in the center portion of the element were found to be reddish brown in color (Fig. 3). The color intensifies closer to the feed tube (Fig. 4). Additionally, lot of

Fig. 3. A view of middle portion of the membrane with discoloration.

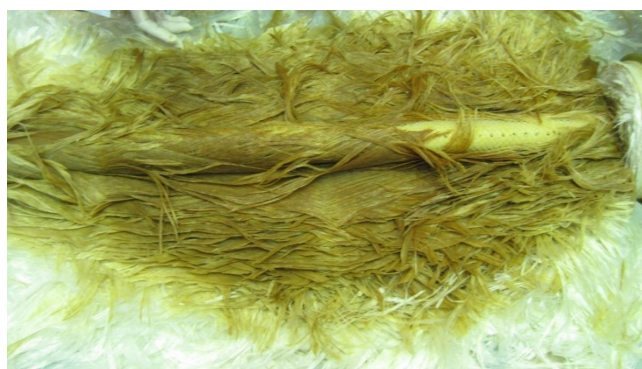
Fig. 4. A view of center portion of the membrane closer to the feed tube.

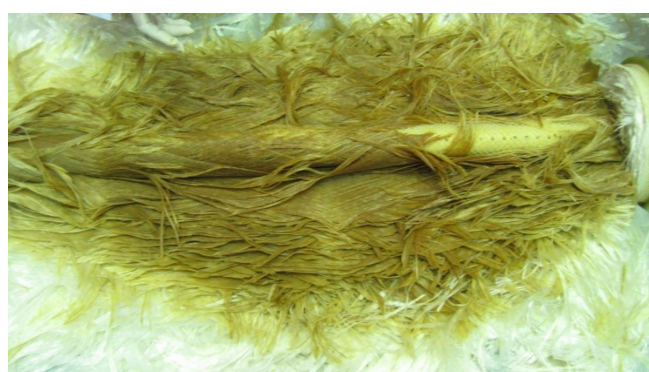
anthracite particle were observed on the fibers near the feed tube (Fig. 5), indicating defects in cartridge filters.

Fig. 5. A view of inner portion of the membrane close to the feed tube showing anthracite particles.

The autopsy reveals that the membrane element was fouled by a mixture of organic matter, fine silt and iron oxides. Biological fouling was absent as evident from lower organic content of less than 50%. SEM images did not indicate any biological activity. Iron oxides could have originated from corrosion of stainless steel parts as evident by the presence of Cr and Ni and also due to the coagulant usage. Presence of fine silt on the membrane surface indicates inadequacy of pretreatment in preventing particulate fouling. Hence, the pretreatment has to be enhanced to handle particulate fouling. Also, presence of anthracite particles indicates failure of cartridge filter.

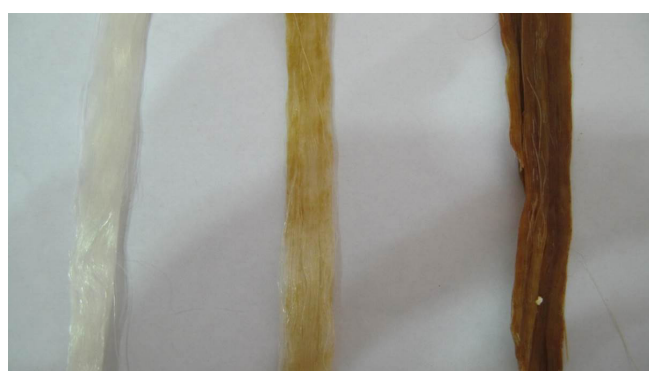
A distinct color difference among the fibers obtained from different sections (outer, middle and inner) is quite clear as shown in Fig. 6. This pattern is typical in hollow fine fiber (HFF) membrane where most of foulants get trapped on the fibers close to the feed tube. These foulants were found to loosely adhere to the fibers. Additionally, an unpleasant odor was detected indicating possible organic or biological fouling origin.

Fig. 6. Distinct color difference among the membrane fibers collected from outer, middle and inner portion of the membrane (from left to right).

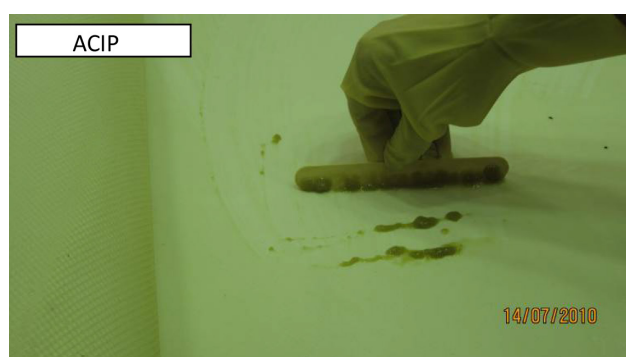
Similar to BCIP, ACIP also had uniform coating of foulant with absence of reddish brown color and having more water content (Fig. 14). Deposits on ACIP also could easily scraped off the surface (Fig. 15). In addition, no foul smell was detected on either membranes. The distinct color dif-

Fig. 15. Foulant being scraped off from the ACIP membrane element.

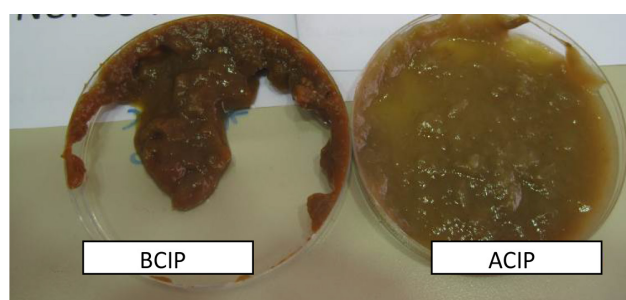
Fig. 16. View of foulant collected from both membranes.

ferences of deposits removed from membrane are quite apparent in Fig. 16, where the higher water content on ACIP membrane deposits is clearly evident.
