Application of external prestressing combined with enlarged section method to reinforce T-beam of approach bridge to reduce seawater corrosion

This paper takes the quay approach bridge of Ningbo Port Phase II as the research object. According to the site investigation of the damage of the T-beam of the upper structure of the approach bridge, the causes of the damage are analyzed, and the method of external prestressing combined with enlarged section method is proposed for the most seriously damaged D-level T-beam. The engineering practice shows the rationality and effectiveness of the combined reinforcement method.

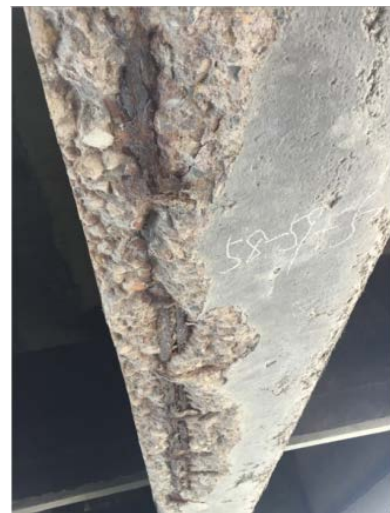
According to Li [6], the on-site investigation of the approach bridge found that the T-beams were seriously damaged, and the main types of damage to the core rod were concrete hollowing, cracking, rusting and exposed rebars etc. In terms of core rod position, the hollowing mostly occurred on its bottom surface, the cracking occurred on the lower edge and bottom of its side, which was mainly caused by rebar corrosion along the tendon cracking, the rusting occurred at the cracks on the bottom of both ends, the partially exposed rebars generally occurred on the underside and the area was mostly 0.1 m × 0.1 m to 0.2 m × 0.2 m. Typical damage types of T-beams are shown in Figs. 2 and 3.

Fig. 2. Exposed T-beams.

reinforcement, based on relevant research and regulations, as well as the appearance of damage, the appearance deterioration degree of T-beams is evaluated as four levels (Level A, B, C, D) [7,8]. Among the T-beams of B-level accounts for 12%, C-level accounts for 78% and D-level accounts for 10%.

In order to analyze the reasons for the damage of the T-beam, further tests were carried out on parameters such as concrete strength, protective layer thickness, chloride ion content, carbonization depth and rebar corrosion potential [6]. The results showed that the concrete strength of the T-beam was between 50.0 and 54.0 MPa, which met the strength requirements of designed 400# concrete. The average carbonization depth was 2.5–4.5 mm, which was far less than the thickness of the rebar protection layer. The thickness of the side protective layer met the specification requirements, however, the average value of thickness of the bottom protective layer was lower than the design value, which did not meet the design and specification requirements. The chloride ion concentration around the rebars at most measuring points exceeded 0.059%–0.107% (in percentage of concrete mass), the rebars were more likely to be corroded. The loss rate of the main rebar section at the damaged place was 13.1%–51.2%, the corrosion shrinkage of rebar was obvious. Considering that the corrosion damage of T-beams was mainly caused by the thin rebar protection layer and chloride ion corrosion, and the loss of local rebar section of some T-beams had exceeded 10%, which would cause prestress loss. According to the different severity of T-beam damage, in order to ensure the safety and durability of approach bridge operation, corresponding repair and reinforcement measures were proposed. For the B-level and C-level T beams, a repair scheme using local and sacrificial anodes combined protection was proposed, so as to improve its structural durability. The following focuses on the analysis of the D-level T-beam and the corresponding repair and reinforcement scheme is proposed.

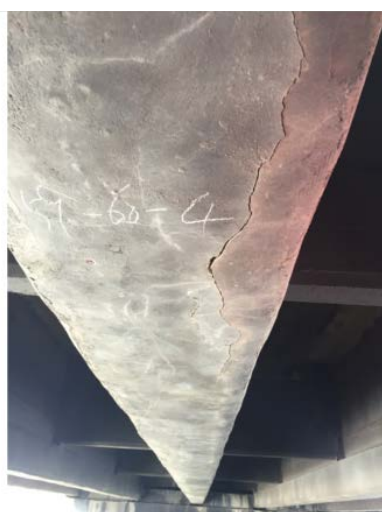
Fig. 3. Hollowing and cracking of T-beams.
