Optimizations for tunnel drainage water system based on locations of crystallizations

Keywords: Tunnel engineering; Calcium carbonate crystallization; Drainage system; Water stop; Inspection well

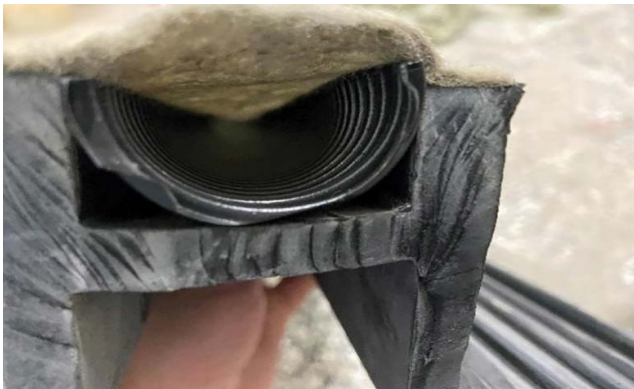
Fig. 8. Schematic diagram of the novel water stop belt structure.

The novel water stop belt consists of geotextile, a groove, water stop belt ribs, water stop belt wings, a fleece layer, and a semicircular hose, as shown in Figs. 7 and 8. The groove is the main part of the water stop belt, which serves to fix the semicircular hose and connect other structures. The concave part at the bottom of the groove allows the water stop belt to be better stressed during installation. The water stop belt ribs are set on top of the water stop belt wings to increase the overall structure's resistance to pull-out force and prevent the water stop belt from deflecting due to concrete vibration during construction. The geotextile is placed at the top to prevent impurity substances such as mud and sand from entering the semicircular hose and damaging the fleece layer, and therefore affecting the anti-crystallization function of the water stop belt and filtering groundwater that flows into the construction joint.

Apart from providing the same sealing performance as ordinary water stop belts, the novel water stop belt also boasts a built-in drainage function. The semicircular hose placed within the water stop belt redirects the groundwater that seeps into the construction joint from behind the lining towards the longitudinal drainage pipe, thus substantially minimizing the water pressure on the water stop belt. In addition, the new water stop belt serves as an anti-crystallization and blockage-preventing device due to setting of the fleece layer.

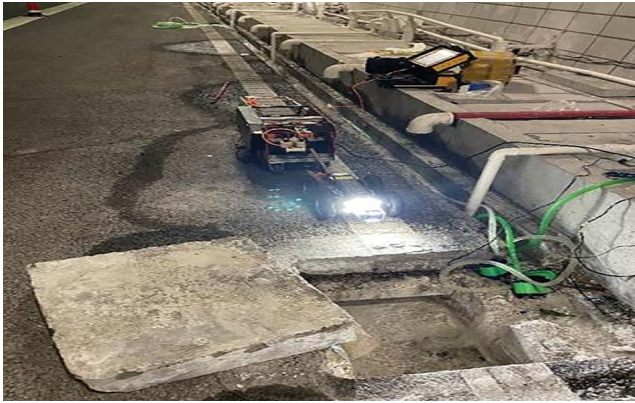
Fig. 10. Tunnel detection by pipeline crawling robot.

Inspection wells serve the purpose of observing and cleaning the blind ditches, providing a visual representation of their blockage status. Keeping these wells unobstructed and maintaining their cleanliness could in part prevent their blockages. Typically, the cleanup of the inspection wells is done by maintenance personnel dispatched by the responsible agency. To ensure uninterrupted traffic flow through the tunnel, this method still suffers from problems such as insufficient prevention measures, limited range of cleaning and observation, high labor costs, and potential safety hazards to the workers involved. To address these issues, inspection wells could be positioned at pedestrian tunnels, where transverse blind ditches could be added and connected perpendicular to tunnel side blind ditches, as

shown in Fig. 10. The blind ditches could then be periodically inspected with pipe-crawling robots. During the tunnel operational period, the inspection wells could be opened on a regular basis for robot inspections to promptly detect and locate any accumulated crystallizations that may cause blockages. This approach requires much less human labor and ensures the safety of the maintenance workers while avoiding disruptions to tunnel traffic [15,16].
