## Biological and corrosion aspects of a multi-stage flash seawater desalination plant after deaerator modification

Deaeration units of a commercial multi-stage flash (MSF) cogeneration facility underwent venting modifications to increase system distillate productivity without increasing energy consumption or elevating top brine temperatures. Three MSF units were investigated after oxygen levels of deaerators spiked above design limits (20 ppb). The investigation found a significant biotic presence in the deaerator unit's MSF heat rejection sections that included algae, bacteria, bivalves, and bivalve larvae. The bivalve taxa consists of *Barbatia parva*, *Diodora funiculata*, *Pinctada margaritifera*, *Amiantis umbonella*, and *Acrostergma assimile*. Galvanic corrosion exacerbated by biofilm was also observed in heat rejection sections. While attesting to the tenacity and adaptability of marine life, the presence of biological communities is symptomatic of the abnormally high oxygen levels in deaerator units. Elevated oxygen levels contribute to systems performance declines resulting from biological fouling of deaerator packing materials, partially responsible for inefficiencies

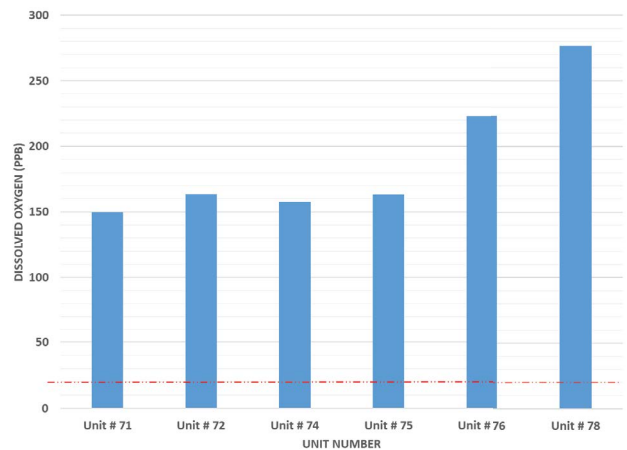
Six deaerator units were examined before their online oxygen measuring systems were calibrated. All units were checked and calibrated with the Orbisphere 3100 portable oxygen saturation device and displayed oxygen concentrations above 20 parts per billion (ppb) – the maximum saturation design limit (Fig. 2). Elevated oxygen concentrations were indicative of a system defect requiring shutdown and inspection.

Fig. 2. Dissolved oxygen measurements of different units within the plant.

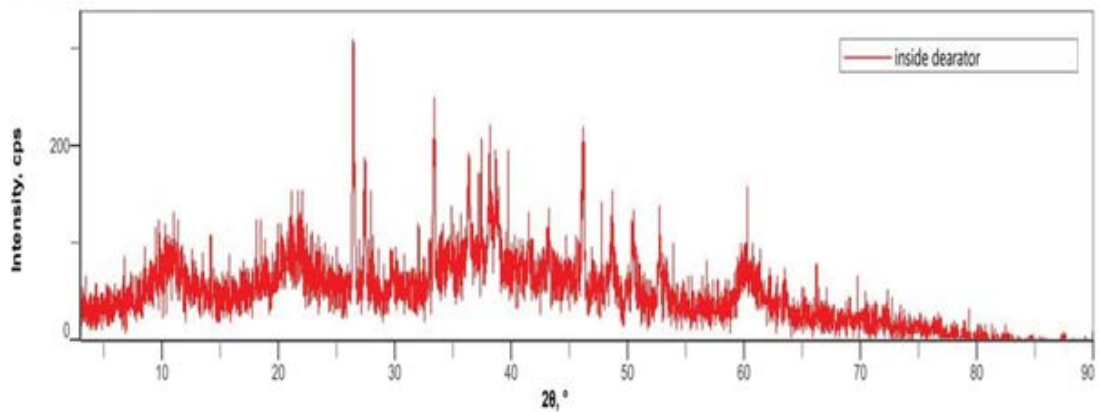
XRD analysis of inorganic samples from the maintenance hole entrance indicates the presence of aragonite (Fig. 8) and a large proportion of poorly resolved amorphous

material (Fig. 8). Aragonite and the high magnesium content from EDX analysis (Fig. 4) are consistent with bivalve biomineralized aragonite production [5]. The absence of sharp peaks is likely due to organic presence within the sample (though samples were cleaned, aspirated, and sequence dehydrated with isopropanol [Fig. 8]).

Fig. 8. X-ray diffraction analysis of inorganic samples from the deaerator manhole entrance.

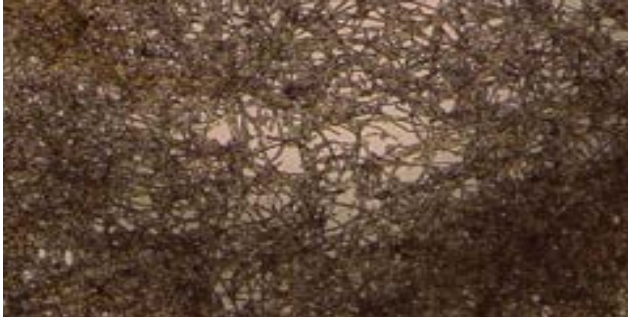
Microscopic analysis revealed that samples from the top of the deaerator manhole entrance (Fig. 6) contained bacterial and filamentous algae as part of the biomatrix (Fig. 9). However, zooplankton species that do not manufacture biofilm were not observed – consistent with chlorination pre-treatment where bivalves and bivalve larvae thrive exclusively on biochemically vulnerable planktonic species.

Fig. 9. Filamentous algae from the biomatrix of samples from the top of the manhole entrance.

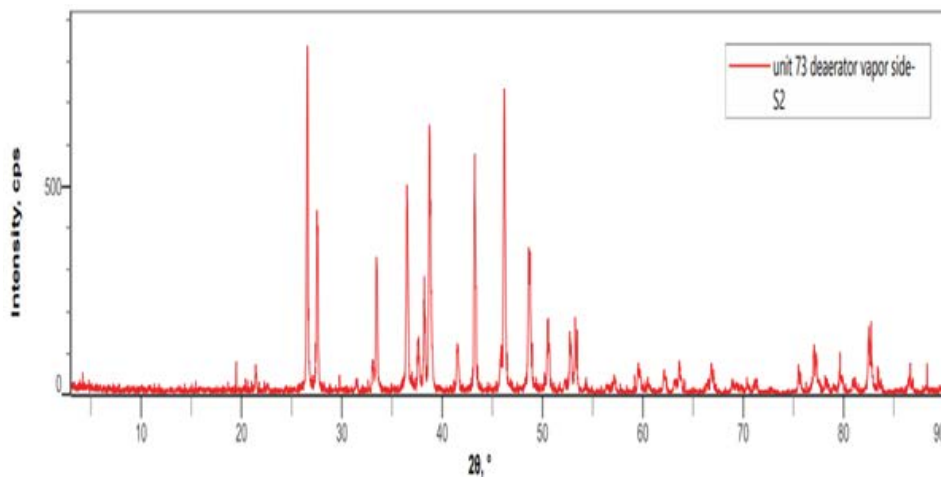
XRD of the hard scale observed on the vapor side of the deaerator contained aragonite – the thermodynamically favorable form of calcium carbonate (Fig. 11).

Fig. 11. X-ray diffraction of deaerator scale from the vapor side above the packing material.

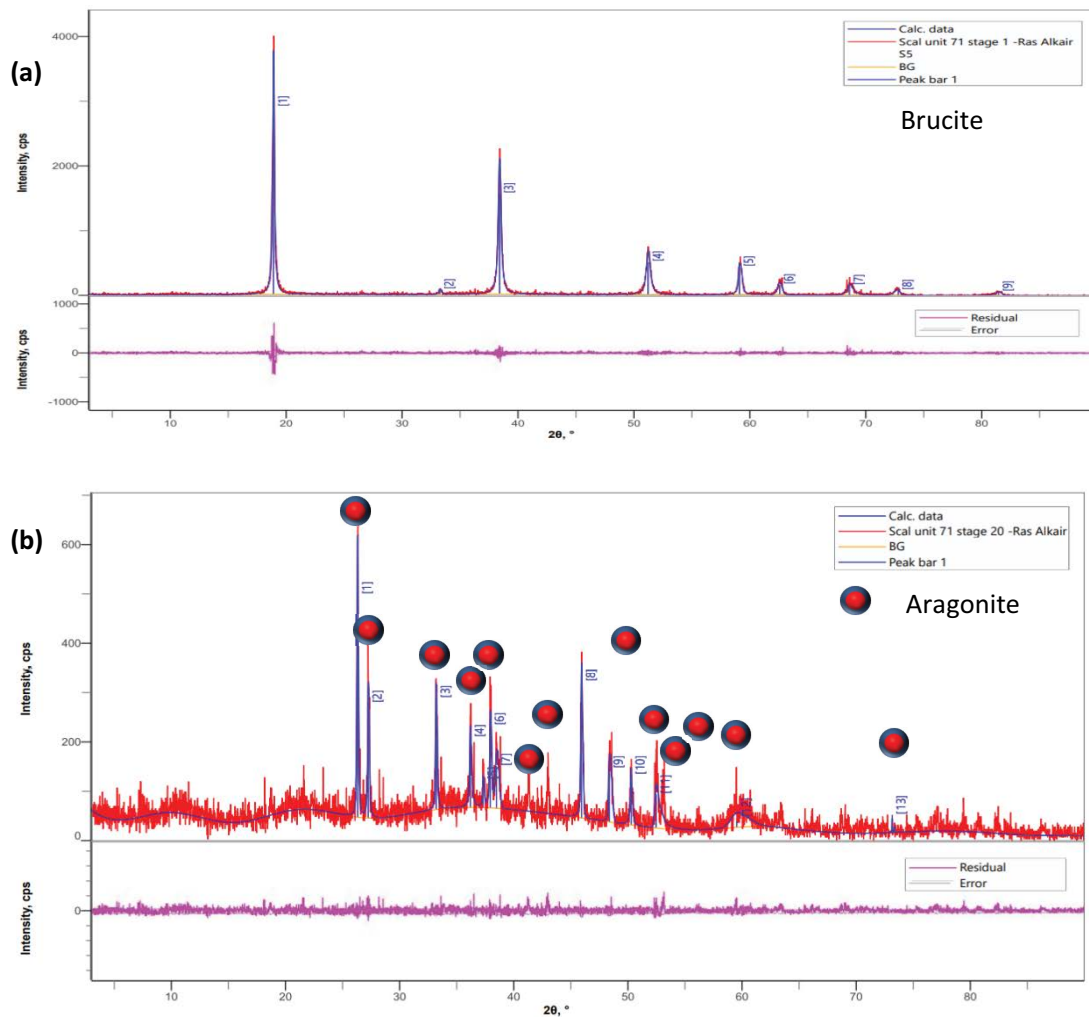
In flash chambers, sand-like material was observed throughout the heat recovery process. The material was collected (from stages 1 and 20) and analyzed using XRD (Fig. 16a and b, respectively).

Fig. 16. X-ray diffraction of sand-like material obtained from the floor of (a) stage 1 and (b) stage 20.
