Investigation studies of vapor side corrosion in a multistage flash desalination pilot plant

A. Al-Arifia*, I.S. Al-Mutaz^b, M.A. Alodan^b, F. Abudaleem^b

ABSTRACT

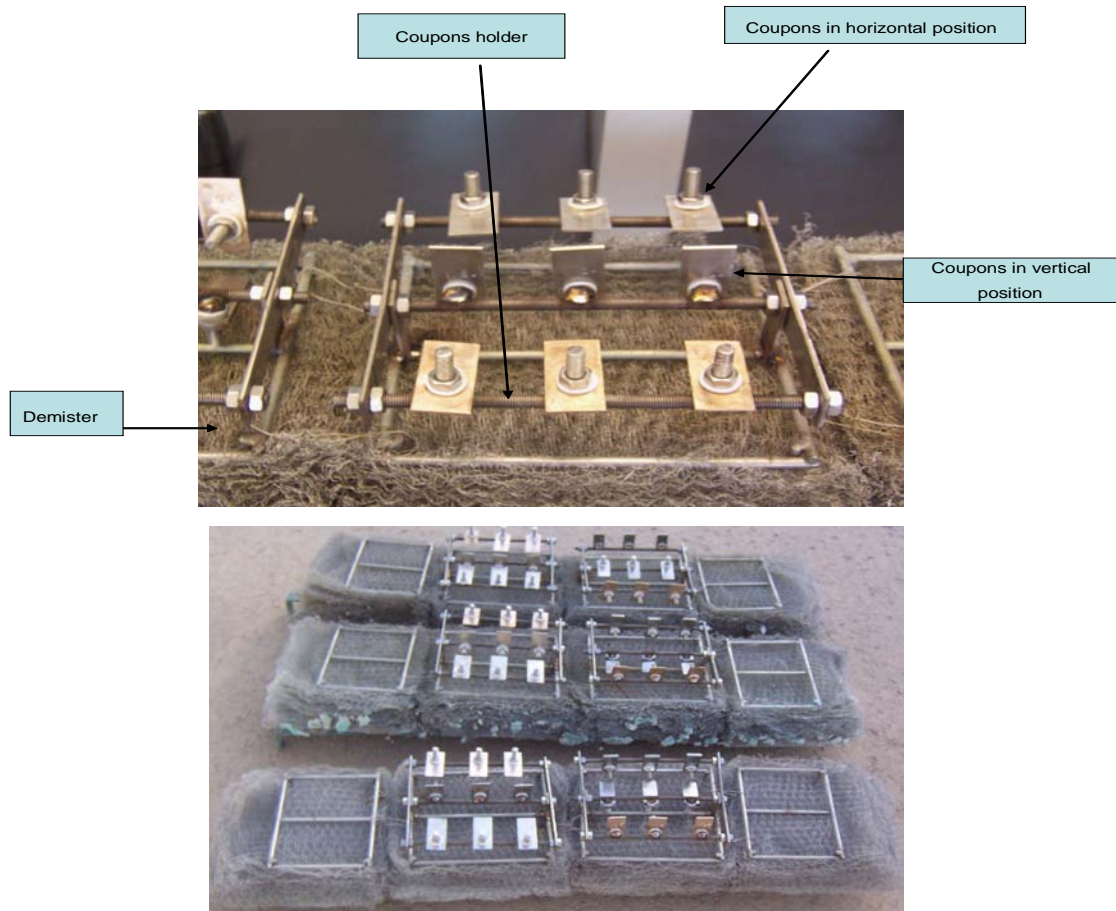
Fig. 4. Upper — the photograph shows the coupon arrangements in stages one, three and five; lower — coupons in the three stages before being placed in the MSF pilot plant.
