Evaluating impact of fouling on reverse osmosis membranes performance

Keywords: Reverse osmosis; Fouling; Autopsy

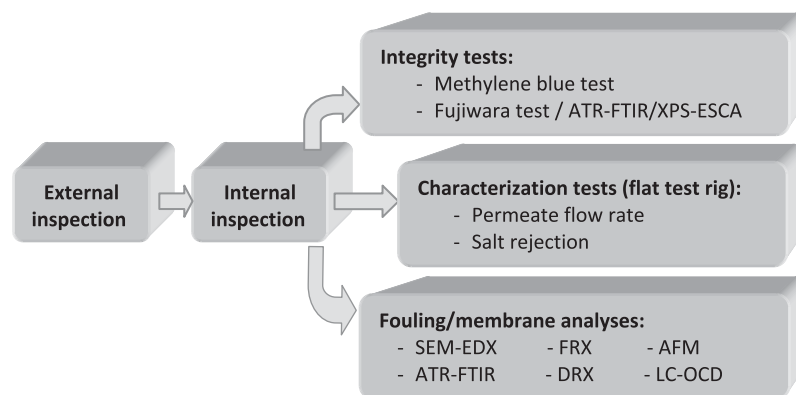
Diagram 1. Schematic description of main analysis carried out in membrane autopsies.

Membrane autopsy is considered as the main tool for identifying fouling nature and establishing membrane failures causes. Next diagram shows schematically different stages and analytical techniques commonly involved during autopsy procedure, which were already explained in previous papers [12] (see Diagram 1).

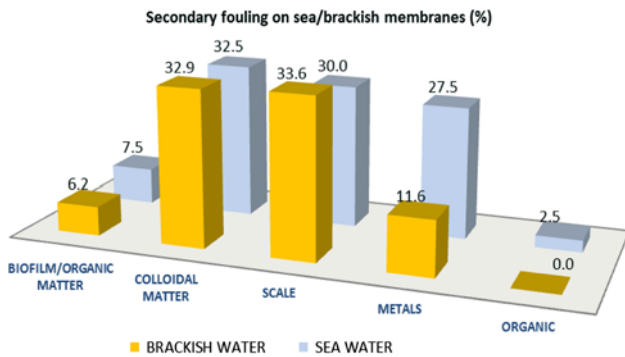
Fig. 5. Secondary fouling composition detected on membranes autopsies (%).

type of membrane, are graphically represented in Fig. 5. This figure verifies that, although some charac-

teristic components are not present on membranes as main foulants (e.g. scaling on sea water membranes), they may be present as secondary components. As figures show, secondary components are mainly inorganic for both kinds of water/membranes. In sea water, special attention should be paid to the presence of metals, since it is a clear consequence of corrosion processes.

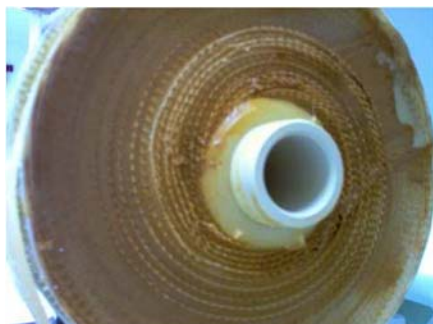
Photograph 16.- Spacer protrusion

Table 2 includes the percentage of membranes with spacer protrusion for each group of fouling detected. As these results demonstrate, spacer protrusion was detected on every type of fouling, although the highest percentage of membranes with this problem was for biofilm. In membranes with biofilm, it is very common to find a relevant presence of the fouling on spacer, which contributes to material displacement (see photographs below) and increase in ΔP . The presence of fouling on spacer material can be found also in scaling processes (as shown in photograph 18).

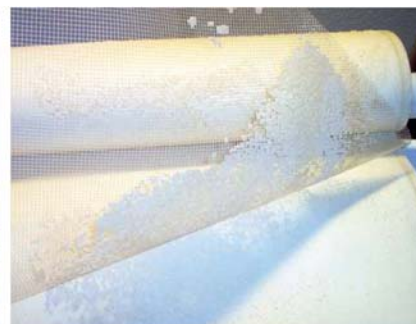
Photograph 18.- Calcium Sulphate scale on spacer

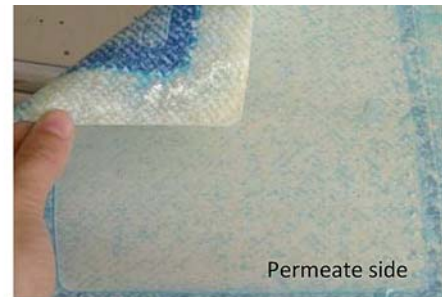
Photograph 21.- Methylene blue test massive positive result

section of membrane is placed in a flat sheet test rig and a blue methylene solution is recirculated through it. Blue methylene is a high molecular weight molecule that should be easily retained by polyamide, unless it is damaged. Thus, if the membrane is damaged, dye passage will be observed on the permeate side of the membrane. Next photographs 19–21 show some examples of membrane coupons after this test.
